# Comparison of Fracture Behavior among Different One-Stage Implants under Cyclic Loading

A Thesis

Master of Dental Science

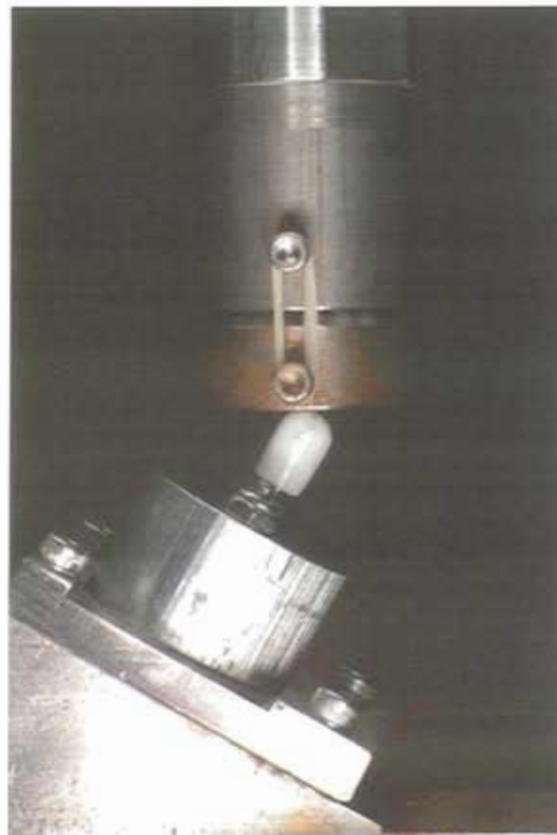
Figure 2. Mounted specimen according to ISO1480.

The embedded implant specimens were mounted at a 30° angle in the stainless steel specimen holding device which was designed to avoid the deformation from the experimental loading condition. The strength and the stability of this holding structure has been tested in a number of past experiments (Figure 2).

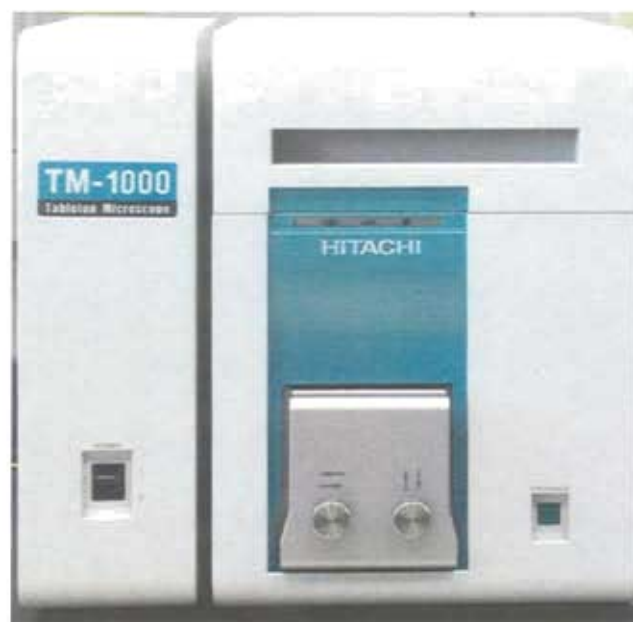
Figure 4. Tabletop Scanning electron microscope

The prepared specimens were evaluated with a tabletop SEM (TM-1000, Hitachi High-Technologies Europe GmbH, Krefeld, Germany)(Figure 4).

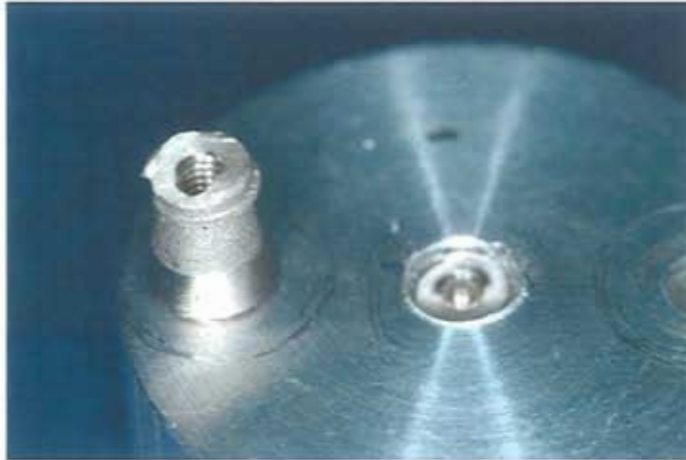
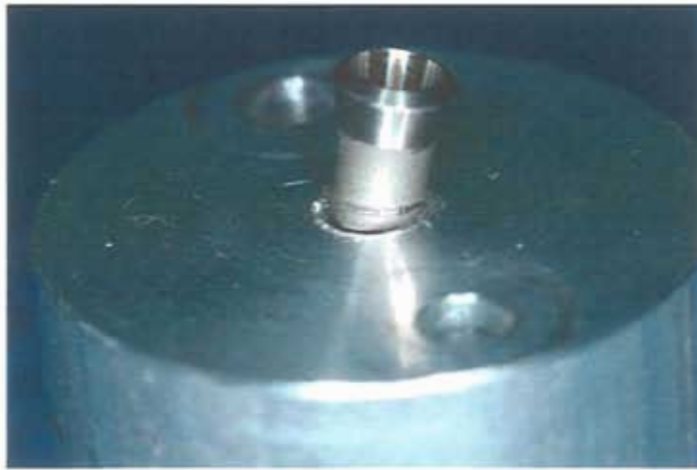
Figure 5. Implant body fracture (Top; Ihdedental #15, Bottom; Lifecore #7).

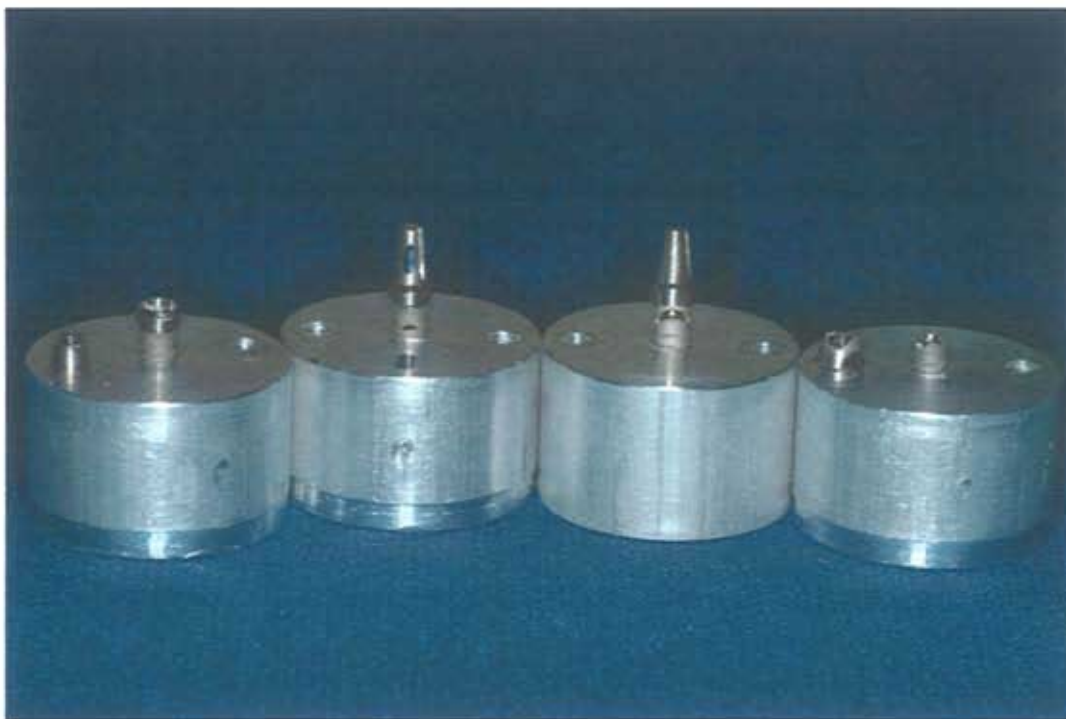
Figure 7. Implant and abutment failure(BlueSkyBio #3,4,8,9).

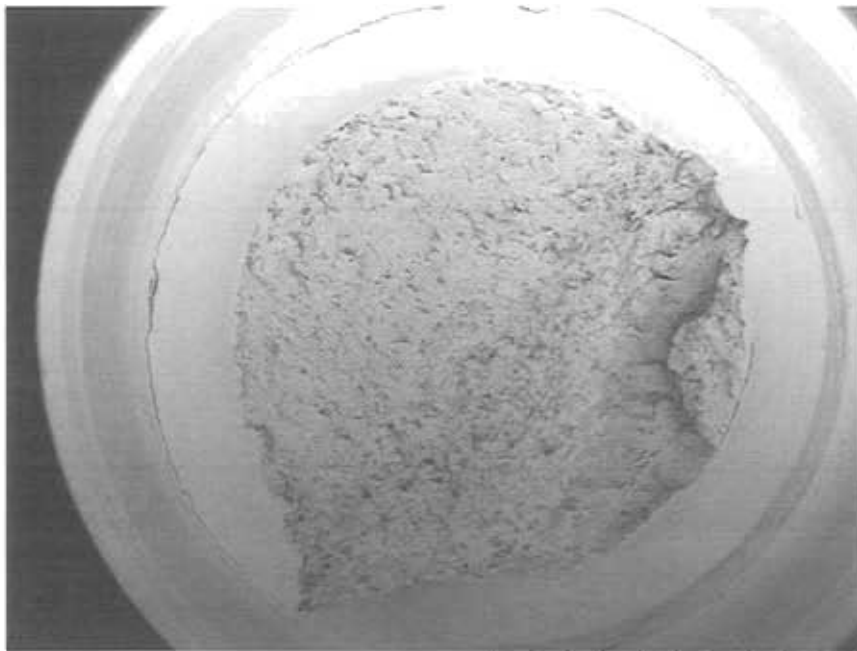
Figure 23. Abutment fracture surface (Ihdedental #4 implant).

Fracture surfaces of Ihdedental implants were virtually identical to the Straumann implant (Figure 20) . The origin of fracture was identified without difficulty and higher magnification showed brittle fracture at the fracture origin (Figure 21). Fatigue striation also presented at the higher magnification (Figure 22). Abutment failed samples also showed fatigue striation in the broken surface but the origin was not as clear as in the SEM of Straumann implant surfaces (Figure 23).

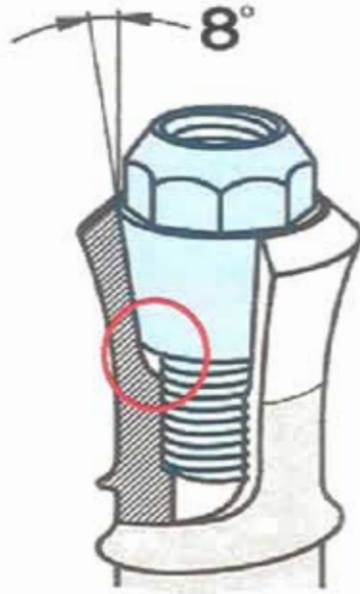
Figure 31. Morse taper

Lifecore stage-1 implant still maintains the original Morse taper design through the entire connection (Figure 31). Meanwhile, the BlueSkyBio implant claims a synOcta compatible connection design (Figure 32). Originally, Straumann changed the Morse taper into the synOcta connection to give more room to the prosthetic option simply by making internal octagonal slot in the internal Morse taper surface of the implant. This modification made the implant wall thinner than the original design. The difference of

The initial crack of the implant in the Lifecore #9 specimen started at the root of the abutment screw where there is small space (red circle in Figure 31). The BlueSkyBio implant started to break at the level of the synOcta indicating slot. In either case, the abutment screw fracture preceded the catastrophic fracture.

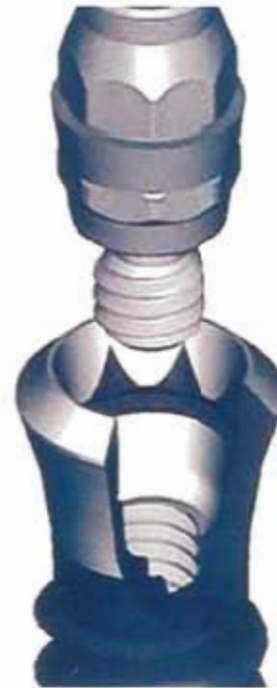
Figure 32. SynOcta design
