Salt-Water Aging, Bonding, and In-Service Performance of a Novel Poured Silicone Expansion Joint Sealant for Small Movement Bridges

A Thesis

Master of Science

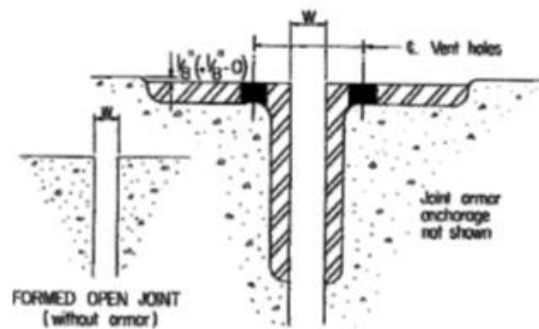
Figure 1: Typical butt joint (Burke, 1989)

The most basic type of joint, the butt joint (Figure 1), is typically used for movement less than 1 inch. The opening is provided between two rigid deck slabs which does not allow a smooth transition for traffic. Typical construction includes using a metal armoring (such as a steel angle embedded into the deck) which acts as the header. This protects the top edge of the deck from vehicle or plow impacts which may cause spalling or cracking. Advantages of the butt joint include simple and cost effective construction; the obvious downside, however, is that it easily allows penetration of water and deicing salts and chemicals, which can promote corrosion of the

substructure. This joint is often found in areas of the country that do not see snow (and therefore ice). It is also preferred that these joints be installed for very small movement bridges (i.e. less than 0.5 inches).

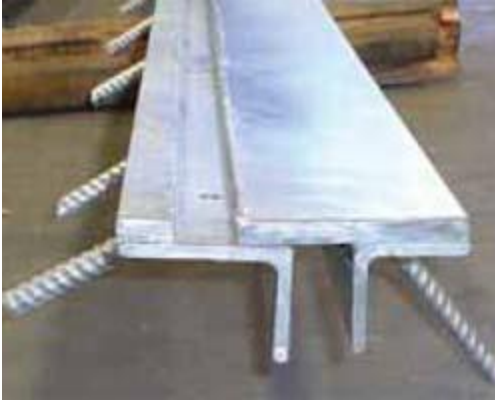
Figure 2: Typical sliding plate joint (Lesa Systems, 2016)

Sliding plate joints (Figure 2) are typically used for movements between 1 and 3 inches and bridge deck spans up to 350 feet. They are simple in construction and are reasonably cost effective. The main idea behind sliding plate joints involves two overlapping steel plates being attached to the deck so that one of the plates is flush with the roadway. The plates slide against each other to accommodate various types of movements. These joints perform well against preventing debris from entering through to the substructure. Due to their reliable construction, they provide a good barrier for a long period of time. The down-side of the sliding plate joint, however, is that they do not provide an effective seal against water intrusion or deicing chemicals. Additionally, small particles of debris such as sand or glass can get stuck in between the plates and cause unwanted friction which may lead to wearing of the plates over time.

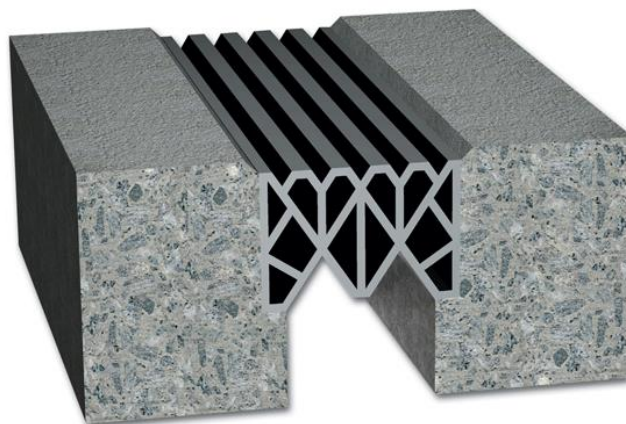
Figure 3: Typical compression seal joint (MM Systems, 2015)

Compression seal joints (Figure 3) are comprised of continuous elastomeric sections with an internal web structure that allows for expansion and collapse of the seal to accommodate for deck movements between 0.25 to 2.5 inches. Since this seal is comprised of an elastomeric material, it is very flexible in accounting for horizontal and vertical deck movements. Additionally, the compression seal is effective in sealing the joint from water and debris infiltration. The downside of this joint, however, is that it is highly susceptible to damage from snowplows and other sharp debris. Additionally, this seal may lose its adhesion to the substrate.

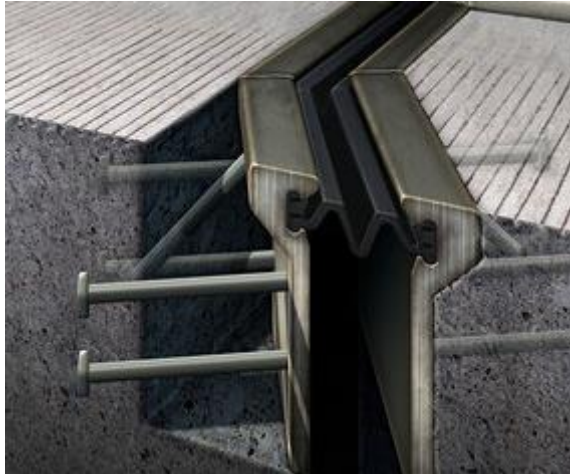
Figure 6: Typical strip seal joint (D.S. Brown, 2015)

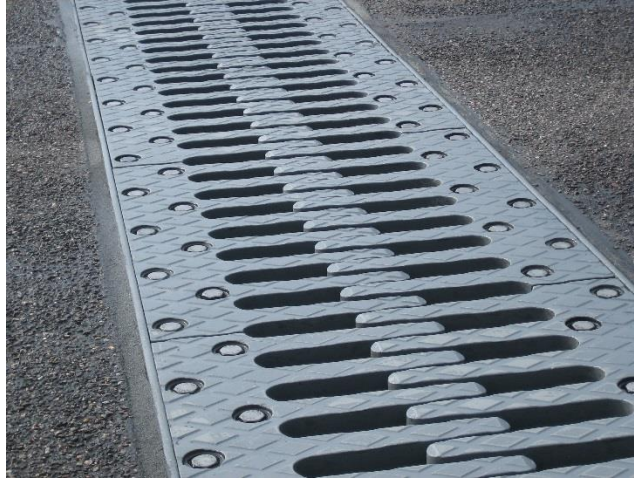
Figure 7: Typical finger joint (Tensa, 2015)

Finger joints (Figure 7), which are applicable for bridge movements of 3 inches or greater, are one of the most dependable expansion joints for larger movement bridges. They allow debris and water to enter, but the diaphragm that hangs between the two bridge decks catches any unwanted material and allows it to flow out to the sides of the bridge deck. Finger joints can accommodate for rotational and vertical movement, which may be crucial for medium movement bridges (especially in seismic regions). Some down sides of the finger joint, however, includes damage to the “fingers” themselves which may lead to them bending upwards. This can result in a rough bump for vehicles or puncturing of the tires. Additionally, the diaphragm that hangs below the roadway must be constantly cleaned to prevent buildup of debris. This operation may prove to be costly and time consuming.

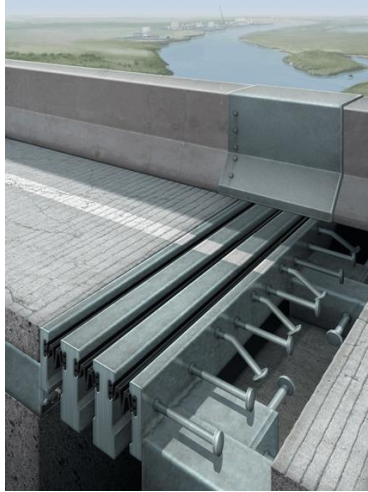
Figure 8: Typical modular bridge joint (D.S. Brown, 2015)

Modular bridge joints (Figure 8), designed to accommodate bridge deck movements as large as 24 inches, are the most complex and expensive expansion joints. They are designed to provide a watertight seal while maintaining smooth wheel load transfer between decks. Since they can accommodate movement up to 24 inches, the joints themselves can be rather large, sometimes spanning over 5 feet. The system mainly comprises of a series of center beams supported atop support bars. The center beams are oriented parallel to the joint axis, while the support bars are placed parallel to the movement direction and are usually embedded into the concrete deck as a monolithic connection. Although these joints are capable of handling large thermal movements, which make them great candidates for long span bridges, the concerns raised with this type of joint include fatigue cracking of welds, damage to the neoprene sealer material, damage from snowplows, and debris getting caught in between the modules. Many departments are reluctant to use modular joints because of their high initial costs and expensive and tedious maintenance patterns.

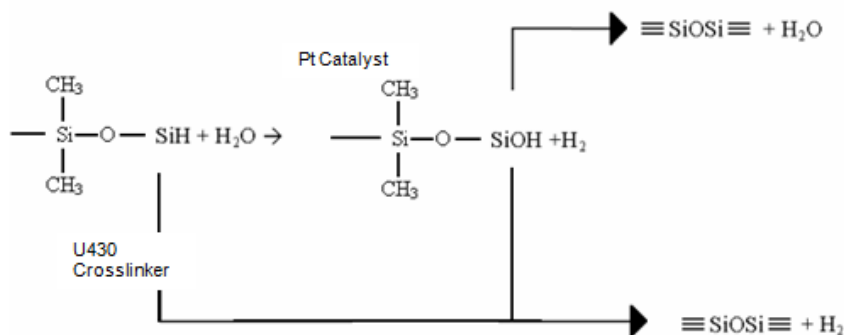
Figure 9: Schematic of Foam Sealant Reaction

Without any additives, Wabo SiliconeSeal (termed “solid sealant” herein) produces a solid, rubber-like material; with the addition of the remaining ingredients, however, foaming of the silicone occurs due to the reaction of water with the added hydrosilane, producing silanol groups and hydrogen gas. As the foam sealant cures over time, the hydrogen gas evaporates out of the mixture and produces bubbles within the microstructure of the silicone, while the silanol groups condense and expedite the polymerization (and thus curing) of the material. A schematic of the chemical reaction is shown in Figure 9.

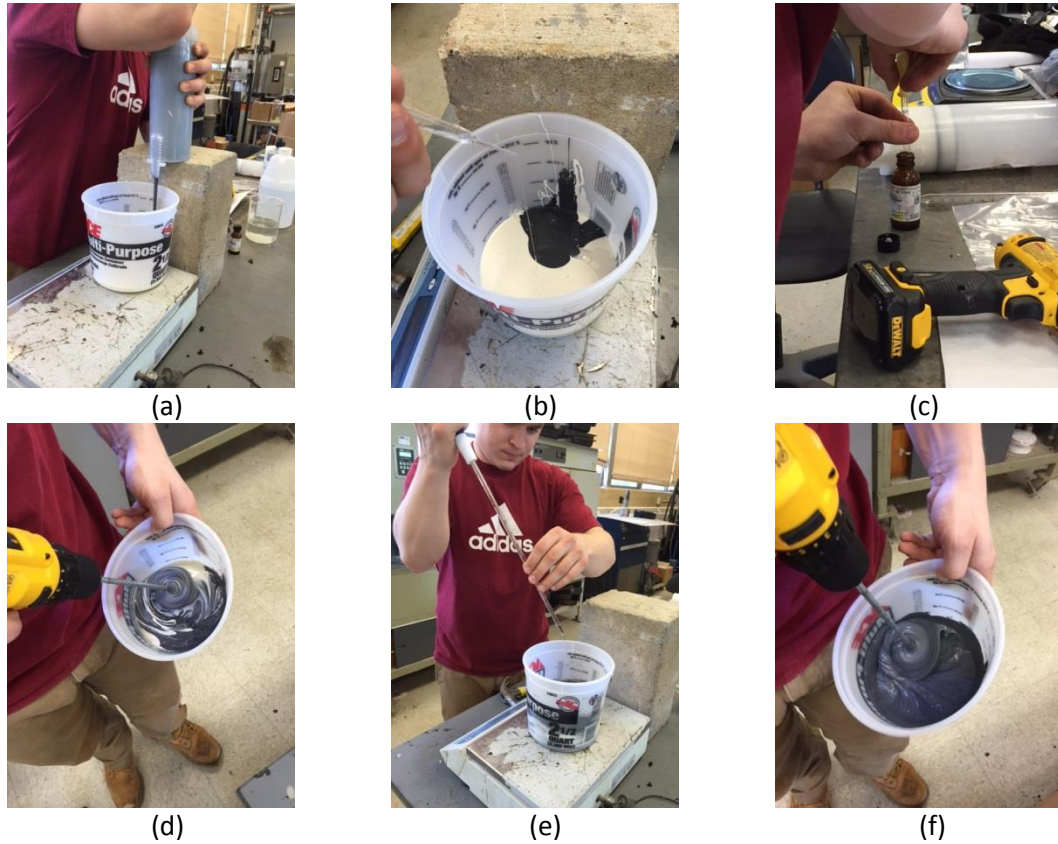
- (a) Pouring equal parts by volume of Wabo black and grey
- (b) Addition of water through dropper
- (c) Addition of platinum catalyst through dropper
- (d) Mixing of first four ingredients for about 45 seconds (time varies with initial volume)
- (e) Addition of crosslinker with pipette
- (f) Mixing of all five ingredients for about 45 seconds (time varies with initial volume)

A consistent mixing procedure is important, especially because a small deviation in quantities added or mixing technique can alter the properties of the foam sealant. Care was also taken to mix enough material to ensure the same batch of material was used for each experiment without mixing more material for the same set of specimens. The mixing procedure is illustrated in Figure 11.

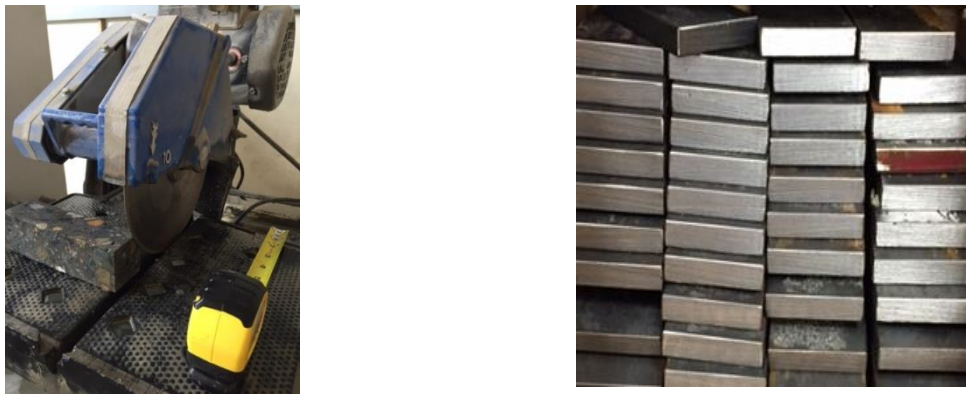
Figure 12: Fabrications of coupons for experimental testing

The tension/adhesion experiment's test coupons were made of concrete and steel, the two most common substrates found in newly constructed bridges. First, the appropriate materials were obtained to adequately replicate those present in the field. With the assist of the Connecticut Department of Transportation, a large piece of concrete was salvaged from a local bridge undergoing replacement. This was done to reflect the type of concrete in joint headers typically found throughout the state. Steel was also obtained with the assistance from the University of Connecticut's Civil Engineering machine shop. Blocks were fabricated using typical A36 steel, the material commonly found at the joints of bridge decks with angle headers. Each specimen contained a 12.7 x 50.8 x 12.7 mm (0.5 x 2 x 0.5 in.) volume of sealant applied in between two substrate blocks measuring 76 x 50.8 x 12.7mm (3x2x0.5 in.) (LxWxH).

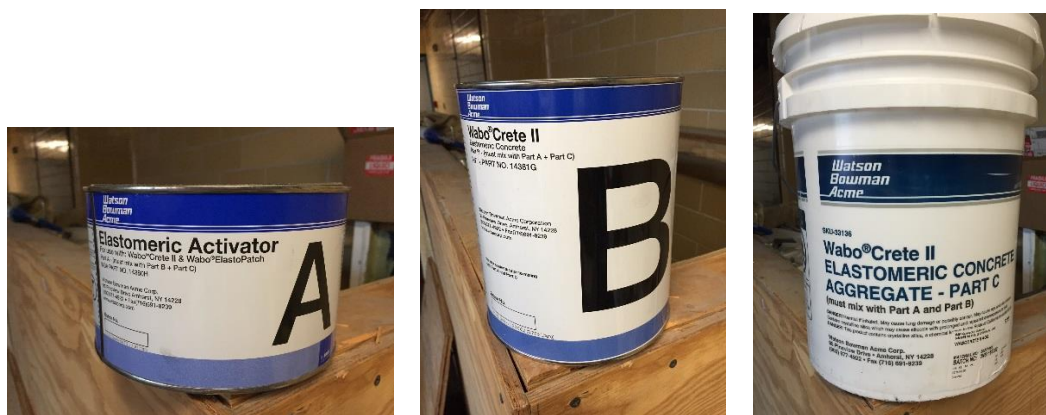
Figure 13: Components of Watson Bowman polymer modified concrete

The substrate chosen for specimens in the aging experiment was a polymer modified concrete (WaboCrete), selected specifically because of its common use in bridge header repair throughout the state of Connecticut. This concrete mix, manufactured by Watson Bowman Acme

Corporation, is comprised of three components: the activator (part A), the resin (part B), and the aggregate. The aggregate contains a particle size distribution between 0.08 and 15mm, having 30-65% passing through a 2mm screen, 12-15% passing through a 0.08mm screen, and 100% passing through a 15mm screen. Per manufacturer specifications, the resin was premixed separately for about 20 seconds before being mixed with the activator in a 5 gallon bucket for approximately 30 seconds. The aggregate was then added until every particle was coated in the mixture. The components are shown in Figure 6.

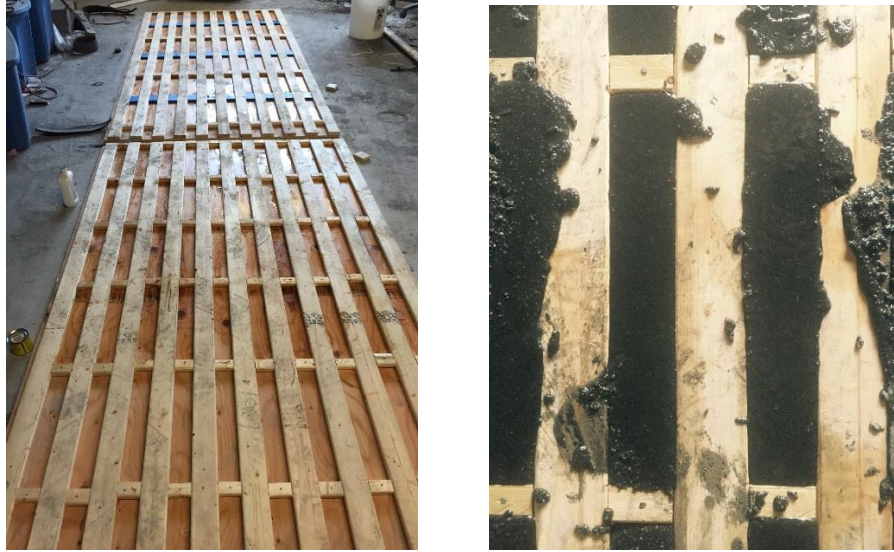
Figure 14: Formwork for polymer modified concrete casting

Forms for the concrete were fabricated and treated with four coats of mineral oil which acted as a release agent. The concrete was poured into forms measuring 317.5 x 50.4 x 12.7 mm (12.5 x 2 x 0.5 in.) (LxWxD); these forms allowed for the concrete to be shaped into 317.5 mm (12.5 in.) bars which would later be cut into individual blocks for specimens (Figure 14). Each bar was shaped up using an angle grinder and sanded to match the exact desired dimensions. Upon 28-day curing of the concrete, the bars were cut into 25.4 x 76.2 mm (2x3 in.) blocks to assemble the specimens. Each bar would yield two specimens since two blocks were needed to assemble once specimen. Once all specimens were cut and cast, they were left to cure at room temperature ($23 \pm 2^{\circ}\text{C}$) for 14 days as shown in Figure 14.

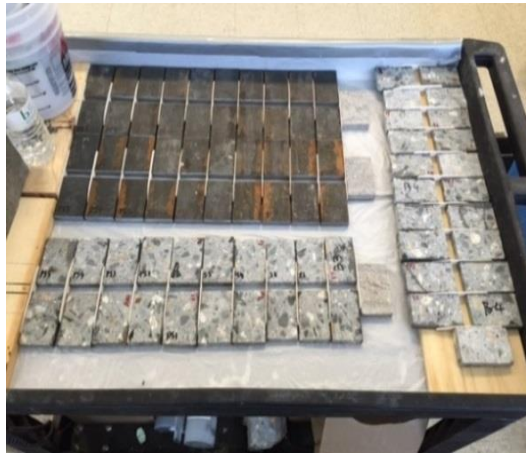
Figure 17: Concrete and steel coupons

Five (5) specimens were fabricated for each variable tested; foam sealant with primer, foam sealant with no primer, solid sealant with primer, and solid sealant with no primer. Since two substrates (concrete and steel) were considered, a total of forty (40) specimens, similar to the one shown in Figure 1, were fabricated for this test. Twenty (20) specimens contained sealant applied in between two concrete blocks, and the other twenty specimens contained sealant applied in between two steel blocks with the same dimensions.

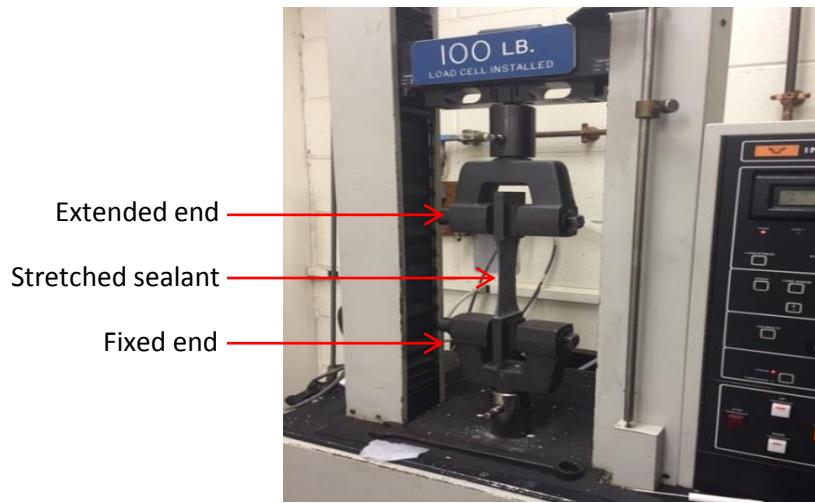
Figure 18: Tensile testing using Instron machine

Upon casting, all forty specimens cured at room temperature ($23 \pm 2^{\circ}\text{C}$) for 14 days. Upon completion of curing, each specimen was labeled and installed at random onto the Instron Model 1011 machine and pulled until failure using a 500 N (100 lb.) load cell. The testing procedure followed specifications outlined by ASTM C1135-00, Standard Test Method for Determining Tensile Adhesion Properties of Structural Sealants (ASTM, 2000). As shown in Figure 18, both substrate blocks were gripped using the mechanical clamps attached to the machine. The lower

end of the specimen's concrete block was fixed while the other concrete block was extended at a rate of 10 mm/min. Using displacement control, the machine recorded the tensile force required to extend the specimen over a specific displacement. From this data, stress and strain information was extracted and computed.

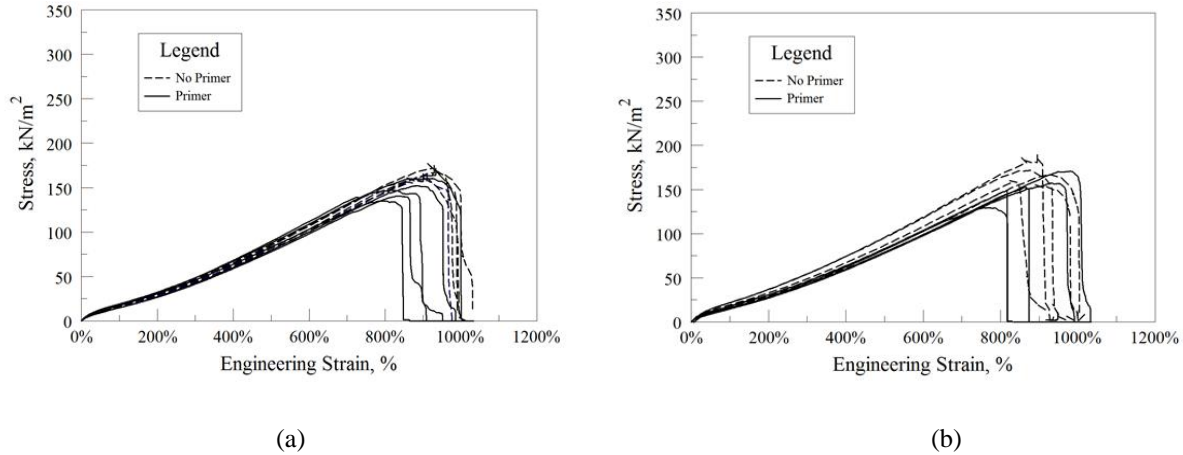
Figure 19: Results for specimens containing (a) foam sealant, steel substrate and (b) foam sealant, concrete substrate

After testing five specimens per variable for each substrate (concrete and steel), both results revealed the foam sealant has a smaller elastic modulus, as illustrated in Figures 19 and 20. This can be observed by comparing the ultimate stresses between specimens containing foam sealant and those containing solid sealant. Specimens containing foam sealant exhibited an average ultimate stress of 155 kPa while maintaining an average ultimate strain of 922.5%. Meanwhile, the solid sealant exhibited an average ultimate stress of 312 kPa with a corresponding average ultimate strain of 1027%. The foam sealant showed a larger average strain, corresponding to an ultimate stress about 49% that of the solid sealant's ultimate stress capacity. While typical civil engineering materials are characterized by their ultimate capacity, this reduction in stress modulus

is actually favorable to reducing the stresses at the interface of the silicone sealant and the bridge header. There was no significant difference observed in maximum stress or strain properties of the specimens between steel and concrete substrates.

The key characteristic that can be taken from this experiment is the failure mode of each specimen. Figures 19 and 20 show the stress vs. strain curves of each specimen; although the strain

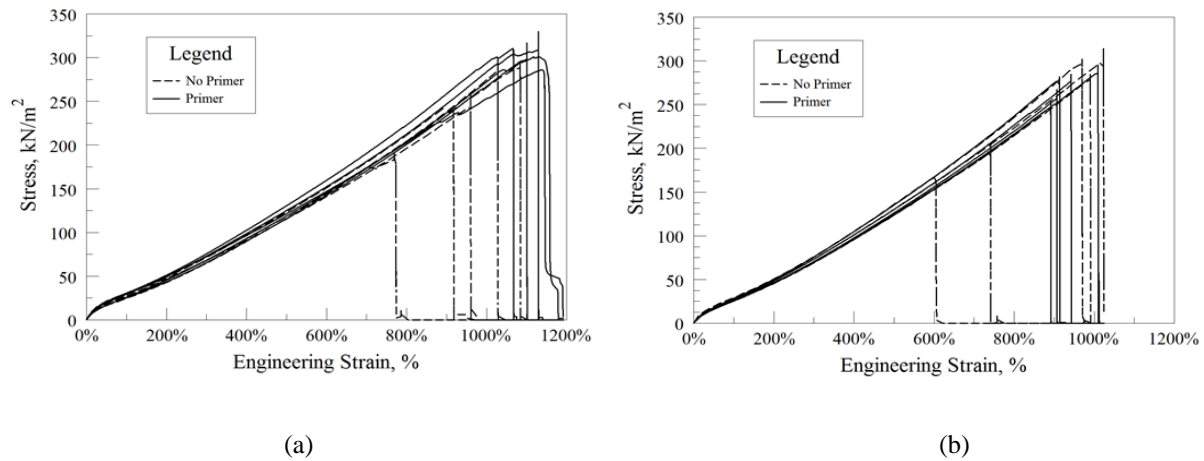
Figure 20: Results for specimens containing (a) solid sealant, steel substrate and (b) solid sealant, concrete substrate

ranges are comparable, and an obvious reduction in modulus is observed in the specimens containing foam sealant, all solid sealant specimens exhibited an adhesive failure, while the foam sealant specimens failed via cohesive failure. Adhesive failure is characterized by detachment of the sealant from the substrate prior to material failure. Cohesive failure, on the other hand, pertains to ripping or shearing of the silicone material itself while maintaining its attachment to the substrate. Both failure modes can be observed in Figures 19-20, as a cohesive failure is characterized by a smooth, rolling peak as the stress approaches its ultimate limit state. Adhesive detachment, however, can be seen when the stress peak sharply drops, indicating a sudden failure under tension. Cohesive failure was observed in 100% of the specimens containing foam sealant for both substrates (concrete and steel). For specimens containing solid sealant, however, 90% of the specimens failed via adhesive failure.

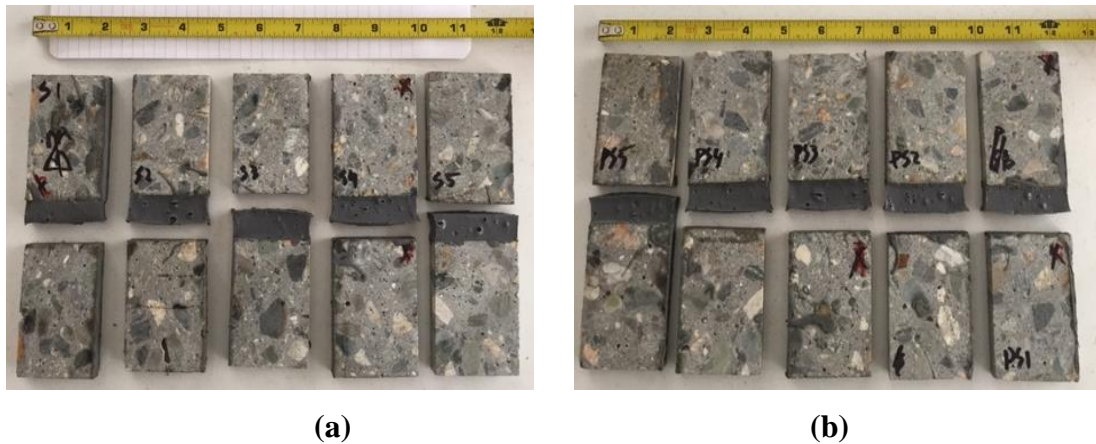
Figure 21: Concrete specimens containing (a) solid sealant with no primer; (b) solid sealant with primer.

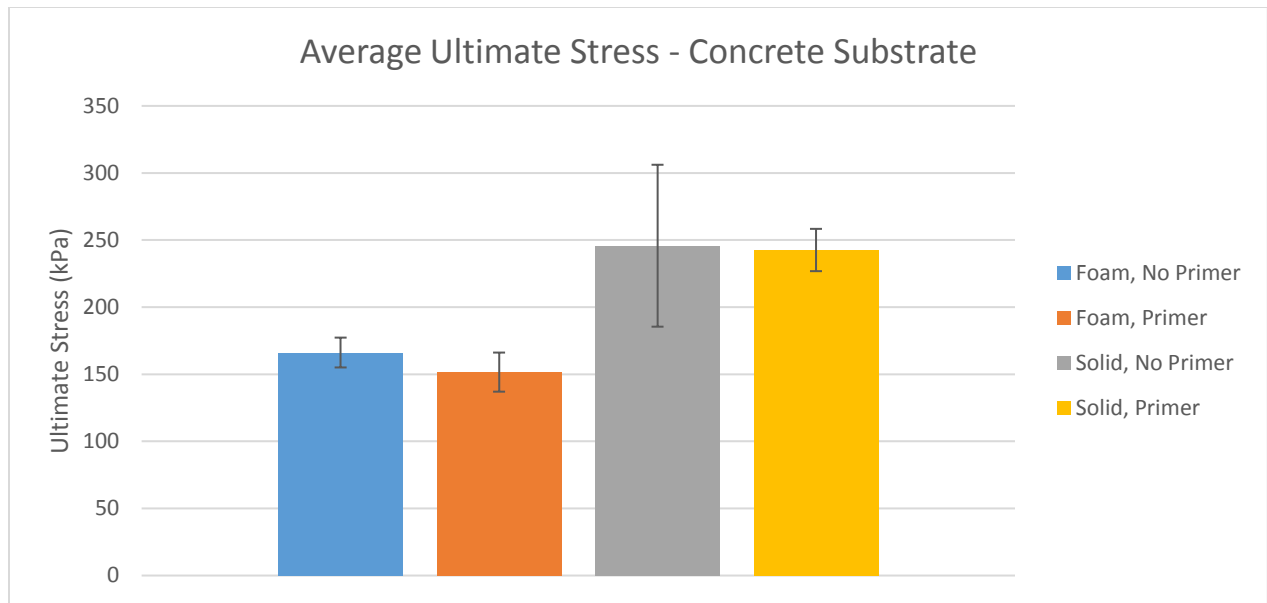
Figure 25: Average ultimate stress for specimens with a concrete substrate

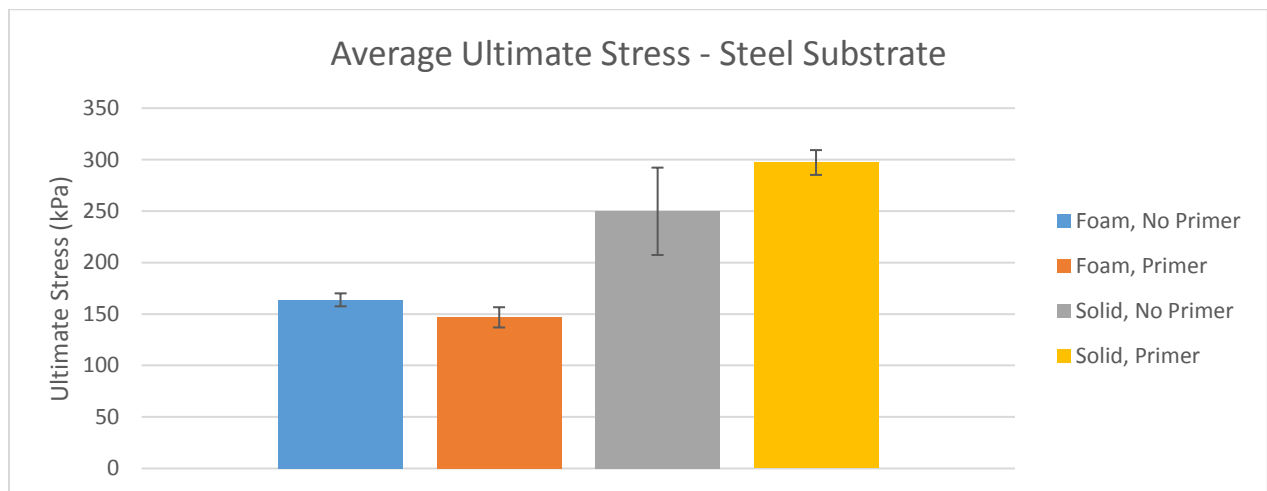
Figure 26: Average ultimate stress for specimens with a steel substrate

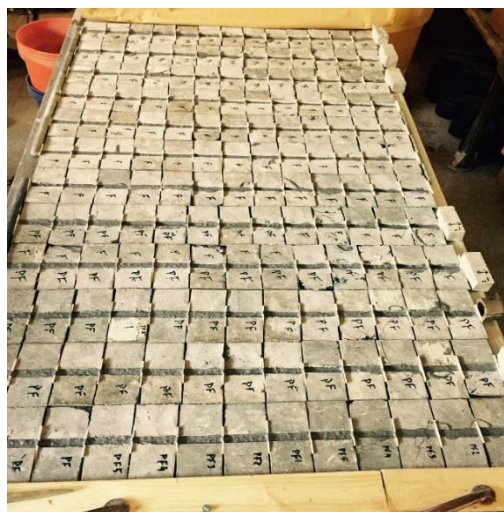
Figure 27: Curing of specimens for aging experiment

Real time aging was simulated by utilizing hot water aging methods as specified in ASTM C1560-03 (ASTM, 2003). It was envisioned that specimens would be extracted at various time intervals and tested for adhesion and tensile strength by pulling them to failure at each respective aging period. Seven testing periods, or durations of accelerated aging, were established: 0 and 14 days, and 1, 2, 3, 4, and 5 months. Five (5) specimens per variable (foam sealant with primer; foam sealant without primer; solid sealant with primer; solid sealant without primer) were cast for each testing period. Therefore, one hundred and forty (140) samples were fabricated to be tested at each time interval including zero days aging. Since the effect of road salt exposure on aged specimens is also of interest, another set of 140 specimens were cast, yielding a total of two hundred and eighty (280) specimens in total.

Each tank was heated to 35°C (95°F) using a 400-Watt submersible water heater with a sensor and activator. Due to the large volume of water, care was taken that the entire tank was heated to the desired temperature prior to submerging the specimens. This was to ensure an even temperature distribution for all submerged specimens regardless of their position in the tank. Three temperature probes were placed inside the tank to monitor the temperature at difference locations throughout the volume of the tank. Since the heater was placed on the bottom of the tank, two probes were attached towards the top of the surface, and one was attached adjacent to the heater. Once all three temperature readings were at 35°C, the specimens were placed into the tanks. The temperature for both tanks was kept to a strict deviation tolerance of $\pm 0.55^{\circ}\text{C}$ ($\pm 1^{\circ}\text{F}$). Temperature profiles of each tank were recorded regularly (Figure 28). The low temperature in each tank observed on day 10 was due to a power outage of the building in which the tanks were located; however, power was restored within 6 hours and the target temperature was regained shortly afterwards.

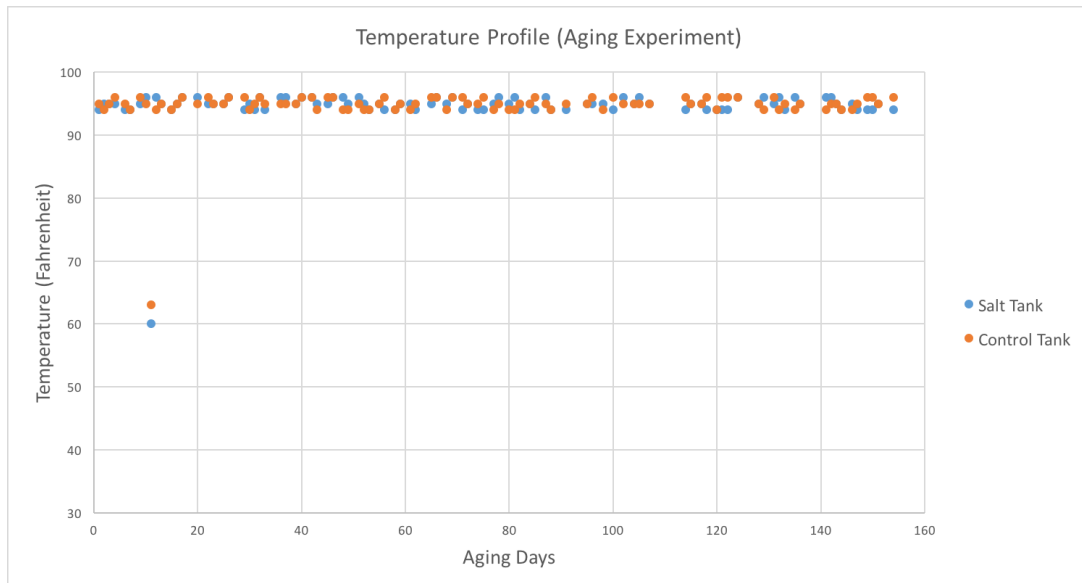
Figure 28: Temperature profile of water tanks

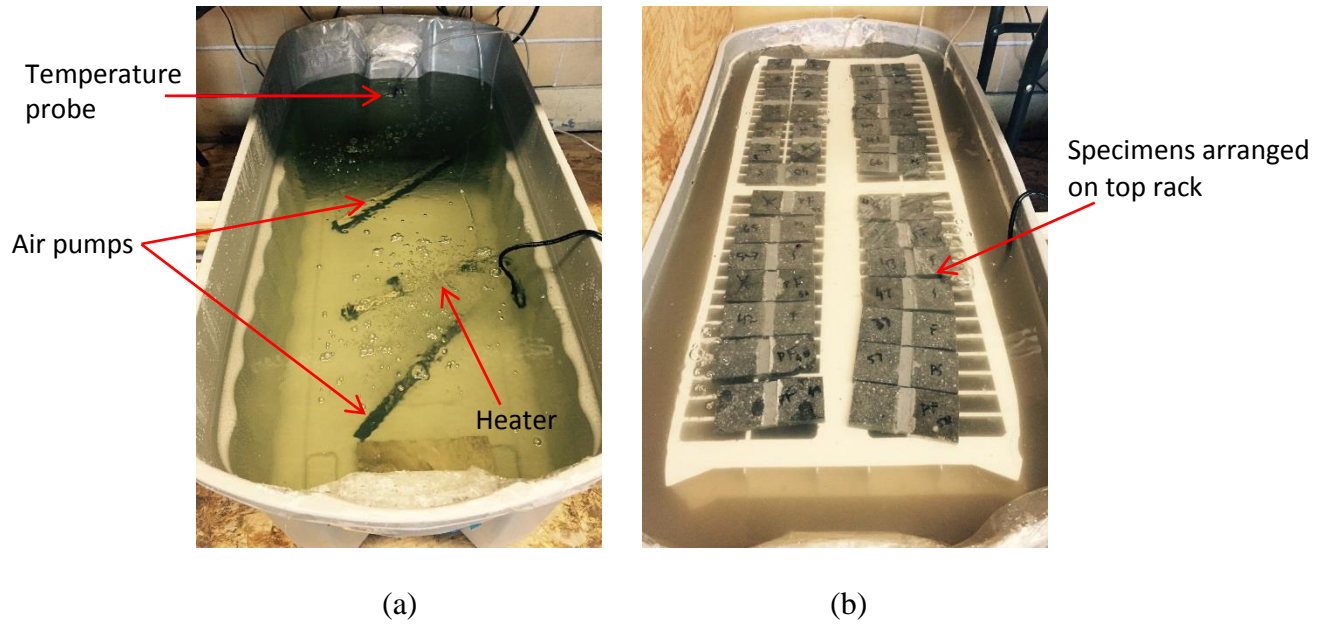
Figure 29: Placement of heater and air pumps (a), water tank containing 140 specimens (b)

To simulate adequate aging, oxygen was delivered to the specimens through two air pumps located at the bottom of each tank. The purpose of these pumps was twofold; they supplied oxygen to the specimens and also provided circulation to the water to ensure an even temperature distribution and prevent any residual salt particles from settling to the bottom of the test tanks. The specimens were arranged on five open area racks per tank, allowing for maximum exposure to the water. Since the water heaters were placed at the bottom of the tanks, the specimens closer to the heater may experience a warmer aging environment. To reduce the proximity bias, the racks were rotated systematically on a regular basis to ensure all specimens experience the same aging environment. Throughout the course of the experiment, the tanks were covered on all sides with insulation to reduce heat loss. The experimental set up is shown in Figure 29.

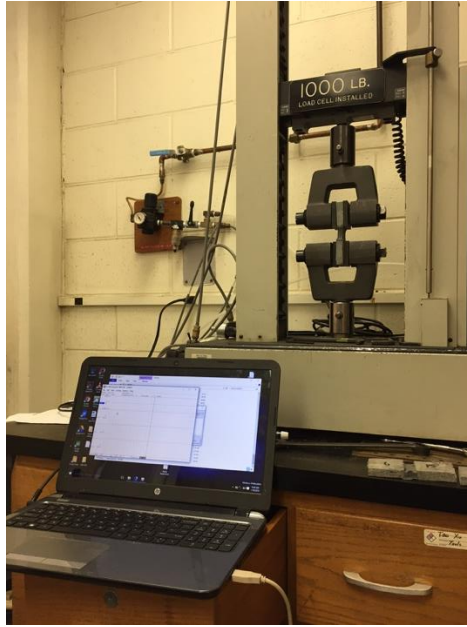
Figure 30: Experimental setup of the aging study

The testing procedure was designed in accordance with ASTM C1135 (Standard Test Method for Determining Tensile Adhesion Properties of Structural Sealants). However, the procedure deviated slightly from the specified standard because a lower rate of extension was implemented (10 mm/min instead of 50mm/min). Similar to the tension/adhesion test, the specimens were installed onto the Intron model 1011 and, using a 1000-pound load cell, pulled to failure. Because of the shape and dimensions of the substrate blocks (the dimensions of the substrate blocked exactly matched the dimensions of the grips), the specimens were mounted in the same way for each test. This was important, as a slight angle offset can induce undesirable shear stresses in the sealant and ultimately result in a different load transfer than what a pure tensile load would induce. Since inherent imperfections existed within each specimen due to the expansion of the foam sealant and general casting method, each specimen's dimensions were measured using a digital caliper, allowing for future adjustments in calculations. Per ASTM standards, the mode of failure, ultimate extension, and ultimate force were recorded upon failure. From these results, stress and strain properties were calculated and tabulated. The test setup is shown in Figure 30.

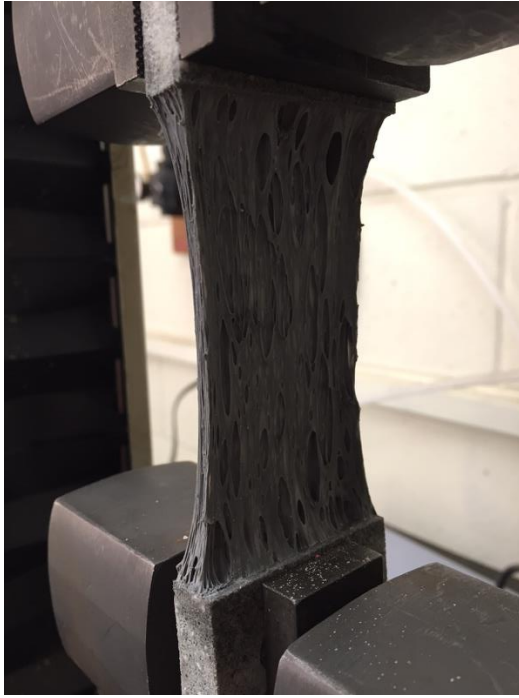
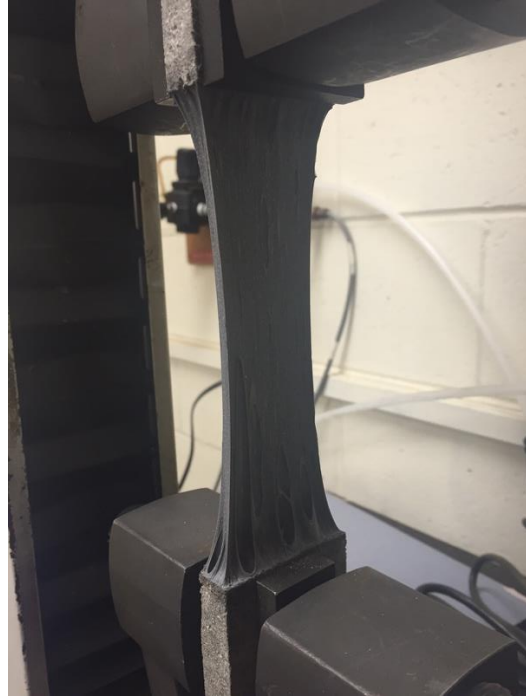
Figure 31: Condition of extended specimens containing (a) foam sealant and (b) solid sealant

During testing, several observations were made. One significant observation was the presence of larger air pockets of the foam sealant, especially when the specimen was extended to a strain beyond 500%. These air pockets seemed more pronounced for specimens that were aged for a longer period of time in the salt water tank. Salt was also observed inside and around the perimeter of the air pockets, suggesting that it the salt particles settled into the air pockets located on the exposed surface of the sealant. However, upon visual inspection of these specimens after failure, no salt was detected within the inner structure of the sealant. Figure 31 shows the extent of the air pockets formed for specimens containing foam (compared to the containing solid sealant).

A common observation among foam specimens was that the cohesive mode of failure initiated at regions where large air pockets were stretched. Upon further stretching, these air pockets began to tear longitudinally, creating weak points in the structure of the sealant. Upon even further extension, the sealant grew thin and eventually yielded, creating a hole in the sealant. Once this hole developed, the remaining sections of the sealant were forced to resist further stretching with a smaller area of sealant. Additionally, stress concentrations were created around the hole where the sealant initially ripped. These regions also began to slowly tear longitudinally, eventually ripping the entire cross sectional area (resulting in a cohesive failure).

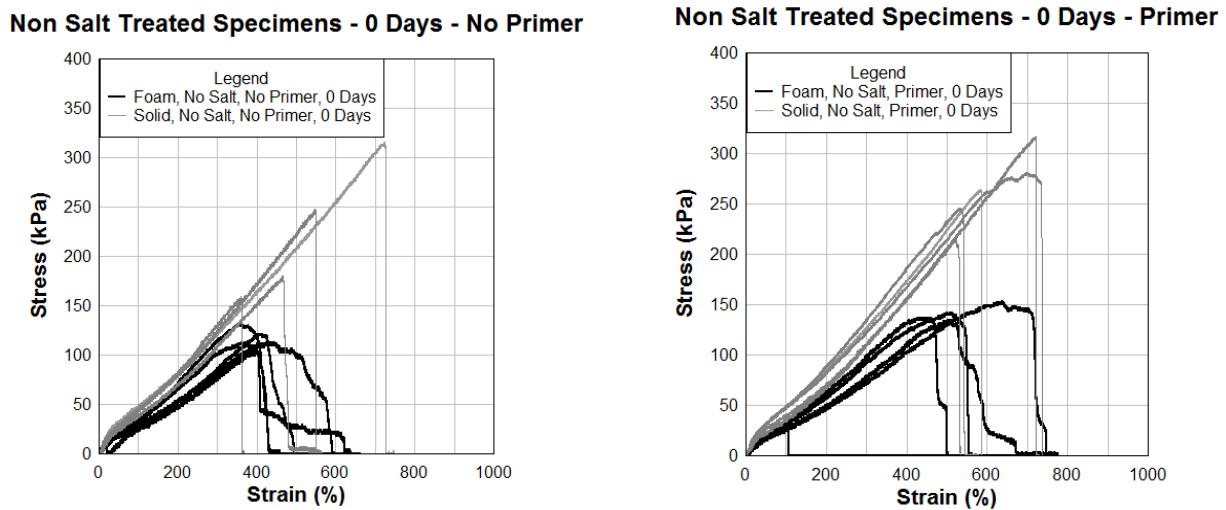
Figure 32: Non salt treated specimens at 0 days with no primer (left) and primer (right)

Figure 32 shows the stress vs. strain curves for specimens tested at 0 days with no exposure to salt. Since these specimens serve as the benchmark prior to any aging, they did not receive any salt exposure. Therefore, only 20 specimens were tested for the benchmark. The curves show that the foam sealant's ultimate stress was more consistent, peaking at just under 150 kPa. The solid sealant, although it achieved a higher ultimate stress, displayed a more scattered ultimate stress at failure, most likely due to imperfections at the interface of the sealant and the substrate blocks.

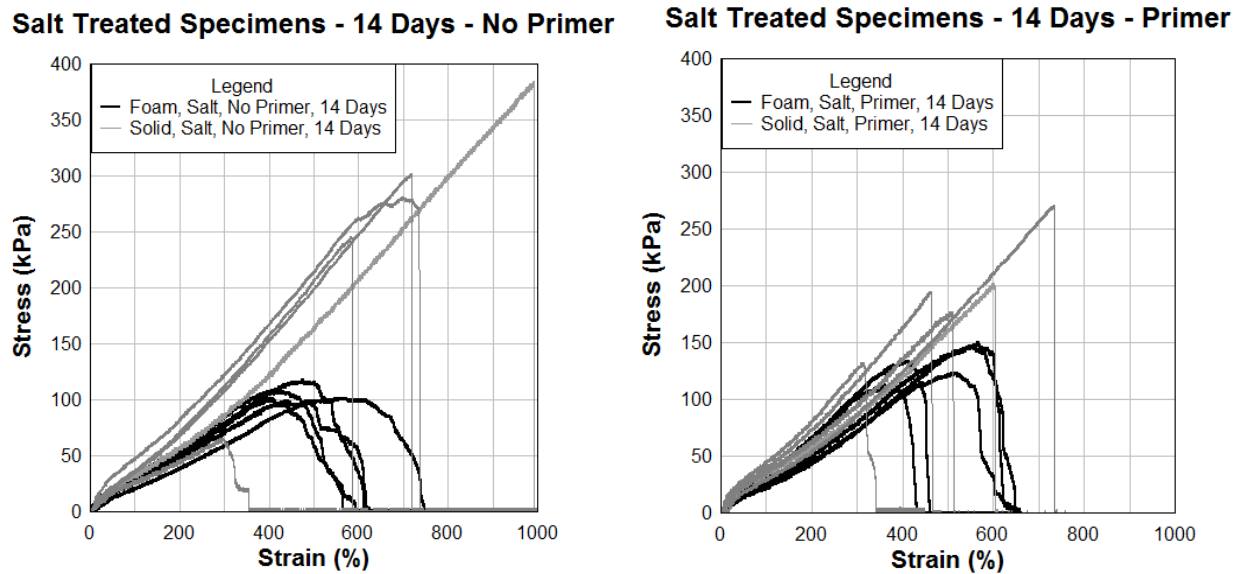
Figure 33: Salt treated specimens at 14 days with no primer (left) and primer (right)

Figures 33-34 show the stress vs. strain curves for specimens after 14 days of aging. The average ultimate stress for solid specimens is just under 300 kPa, while the foam sealant failed at stresses ranging from 120-150 kPa. Almost all solid specimens show a higher modulus of elasticity, even at early loading stages. Almost all foam specimens fail around 600% strain.

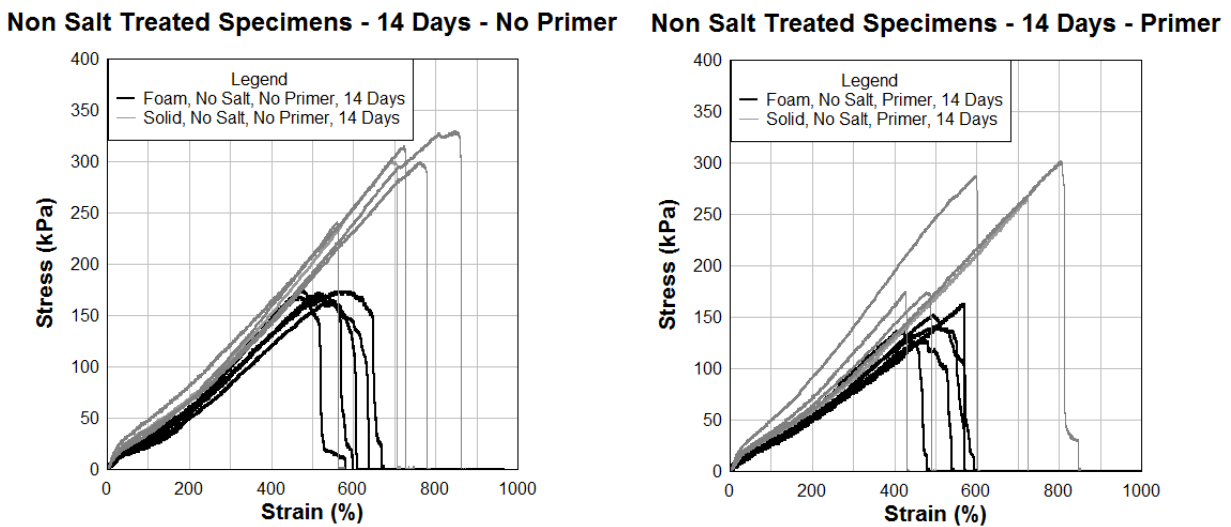
Figure 34: Non salt treated specimens at 14 days with no primer (left) and primer (right)

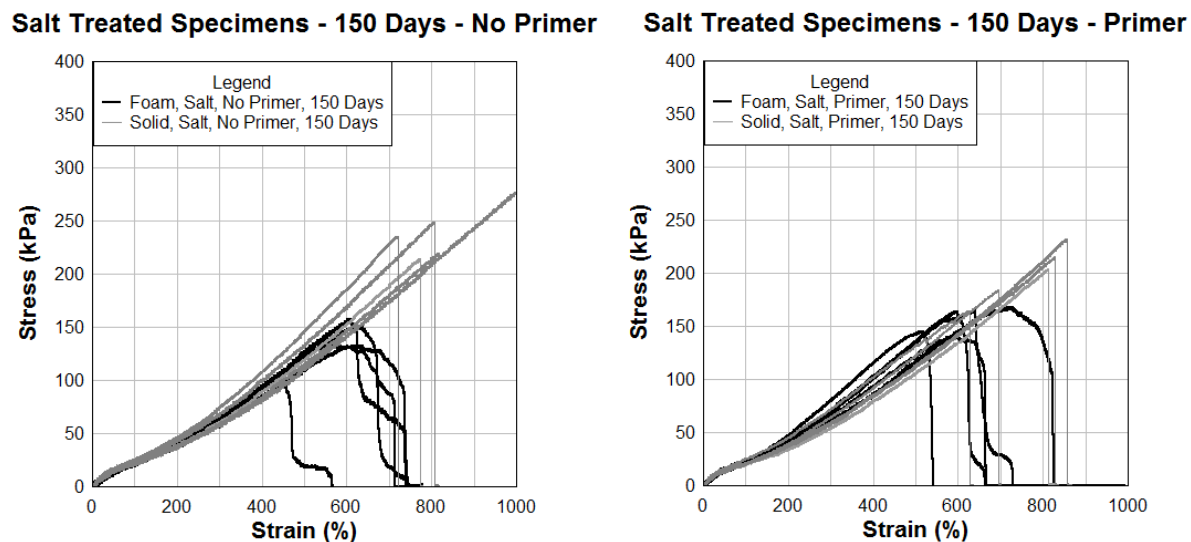
Figure 38: Salt treated specimens at 150 days with no primer (left) and primer (right)

Figures 38-39 show the stress vs. strain curves for specimens after 150 days of aging. The average ultimate stress for solid specimens is just under 230 kPa for specimens exposed to salt. However, the specimens with solid sealant not exposed to salt experienced a larger drop in ultimate stress, peaking at around 170 kPa while the foam sealant failed at stresses ranging from 120-150 kPa.

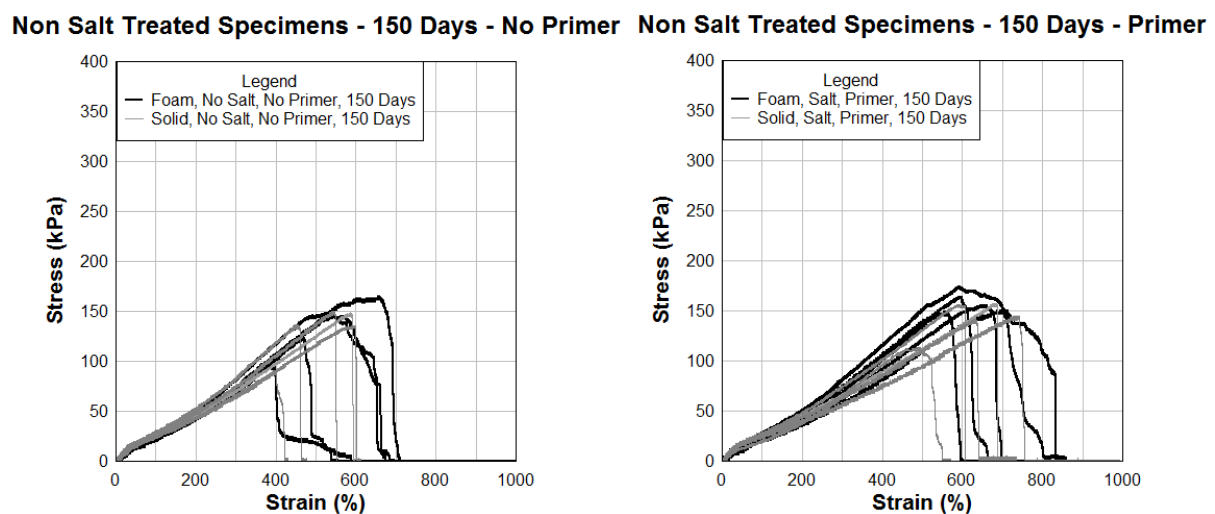
Figure 39: Non salt treated specimens at 150 days with no primer (left) and primer (right)

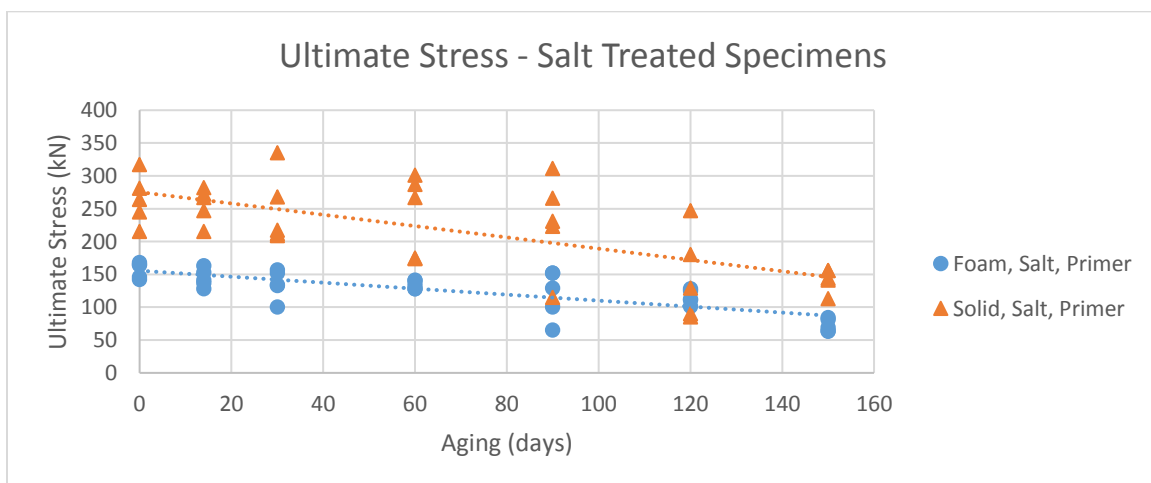
Figure 40: Ultimate Stress for specimens exposed to salt and primer treatment

Figure 40 shows the ultimate stress values for specimens exposed to salt and primer treatment. Judging by the trend lines, it can be observed that the stress at failure for both the foam and solid sealants reduces over time, indicating a possible reduction in modulus. To distinguish a difference in slopes between the foam and solid, a t-test was run and generated a t-value of 3.395 and a probability of 0.001, indicating a statistical difference between the two slopes. This indicates that the rate of deterioration of the solid sealant is greater than that of the foam.

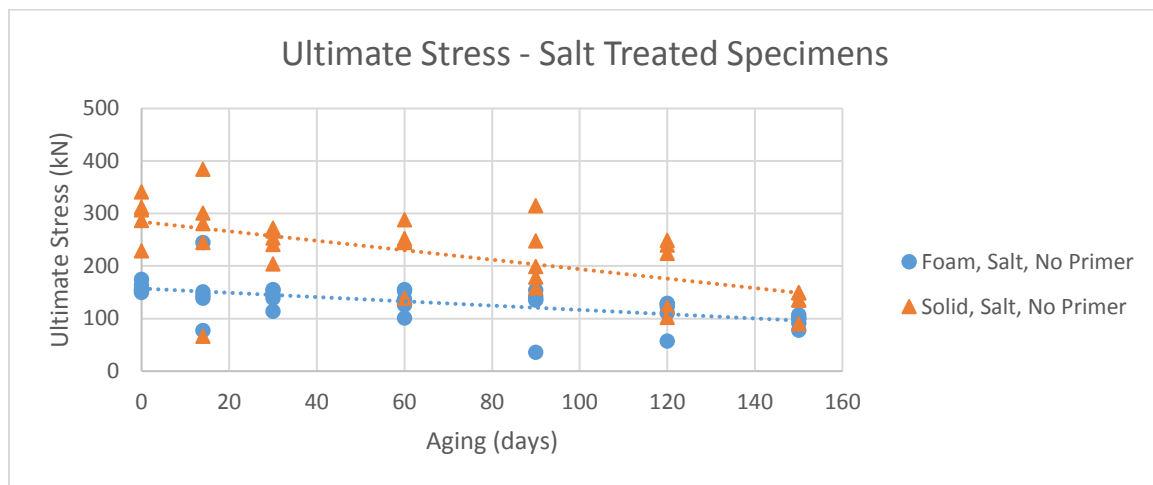
Figure 41: Ultimate Stress for specimens exposed to salt and no primer treatment

Figure 41 shows the ultimate stress values for specimens exposed to salt but no application of primer. Again, it can be observed that the stress at failure for both the foam and solid sealants reduced over the duration of the experiment. When running a t-test to determine whether the difference in slopes is significant, the t-value generated was 2.23 with a probability of 0.03, suggesting a statistical difference between the foam and solid sealant's slopes. This confirms the visual observation of trend lines, as the solid sealant seems steeper.

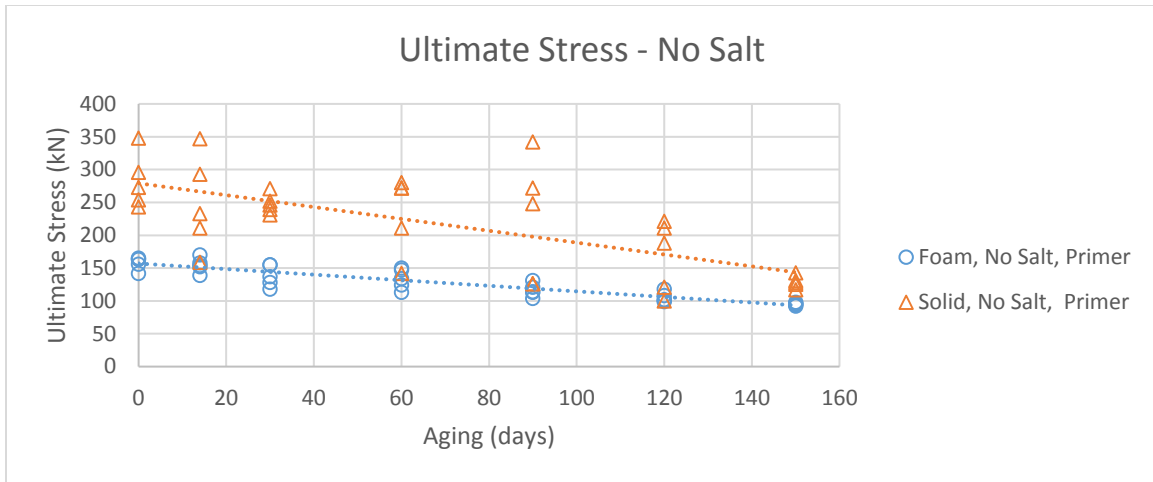
Figure 42: Ultimate Stress for specimens not exposed to salt and primer treatment

Figure 42 shows the ultimate stress values for specimens not exposed to salt but treated with primer. The ultimate failure stresses for the solid sealant is consistent with the other specimens at the start of the experiment (0 days), measuring approximately 280 kN. After 150 days of aging, the ultimate stress of the solid sealant measured consistently at approximately 140 kN, an overall reduction of about 50%. However, the foam sealant's stress at failure dropped approximately 33% over the same time period and aging conditions. The t-test confirmed that the difference in these slopes is statistically significant, as the t-value generated was 2.675 with a probability of 0.011.

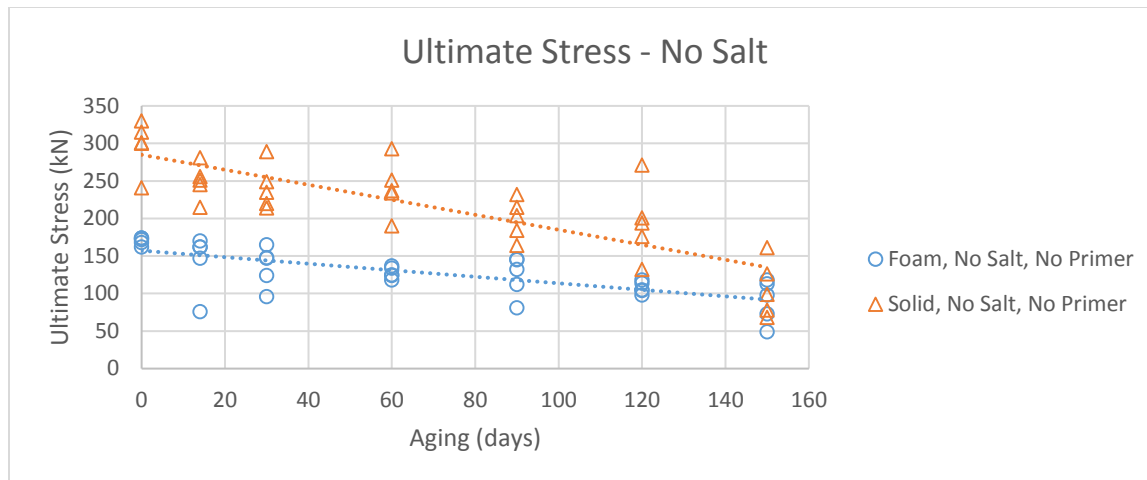
Figure 43: Ultimate Stress for specimens not exposed to salt and no primer treatment

Figure 43 shows the ultimate stress values for specimens not exposed to salt and also not treated with primer. The ultimate failure stresses are consistent with the previous results. Again, the solid sealant exhibits a sharper decline in tensile capacity, indicating its vulnerability to aging itself. The t-test again confirms that the solid sealant's drop in ultimate stress is significant, yielding a t-value of 3.907 with a probability of less than 0.001.
