Salt-Water Aging, Bonding, and In-Service Performance of a Novel Poured Silicone Expansion Joint Sealant for Small Movement Bridges

A Thesis

Master of Science

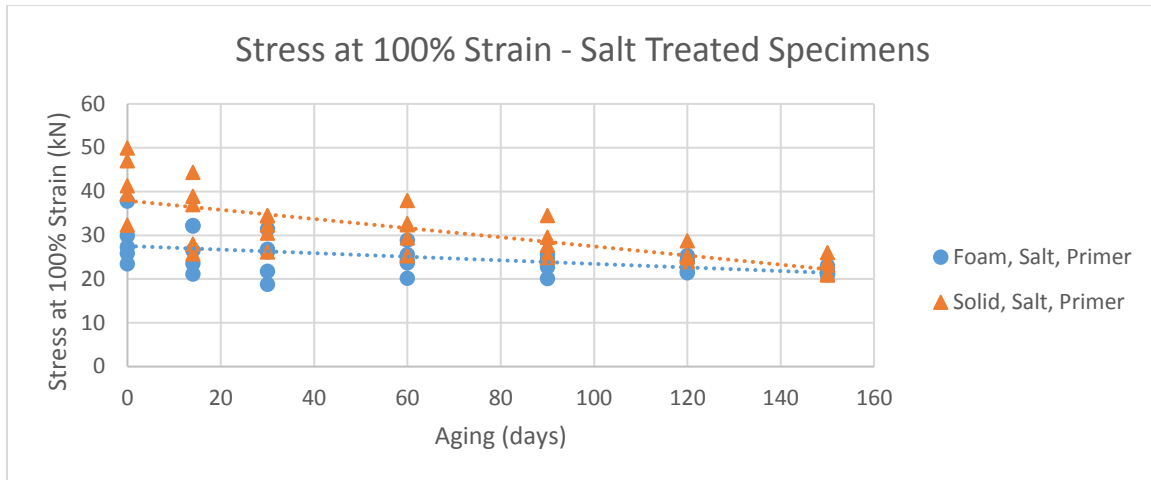
Figure 44: Stress at 100% Strain for specimens exposed to salt and primer treatment

From Figure 44, it can be observed that the modulus of the solid sealant decreases at a higher rate when exposed to salt water aging. The stress at 100% strain of specimens containing primer at 0 days (no aging) was measured to be approximately 39 kN. Over an aging period of 5 months, however, the stress dropped to about 21.5 kN, a reduction of 44.9%. The foam sealant, however, exhibited a more consistent modulus throughout the course of aging. The initial stress at 100% strain was observed to be about 26.9 kN, dropping to about 21 kN after 5 months aging. This represents a reduction in stress of approximately 21.9%. The changes in slope of these points was deemed significant with a t-value of 3.19 and probability of 0.002.

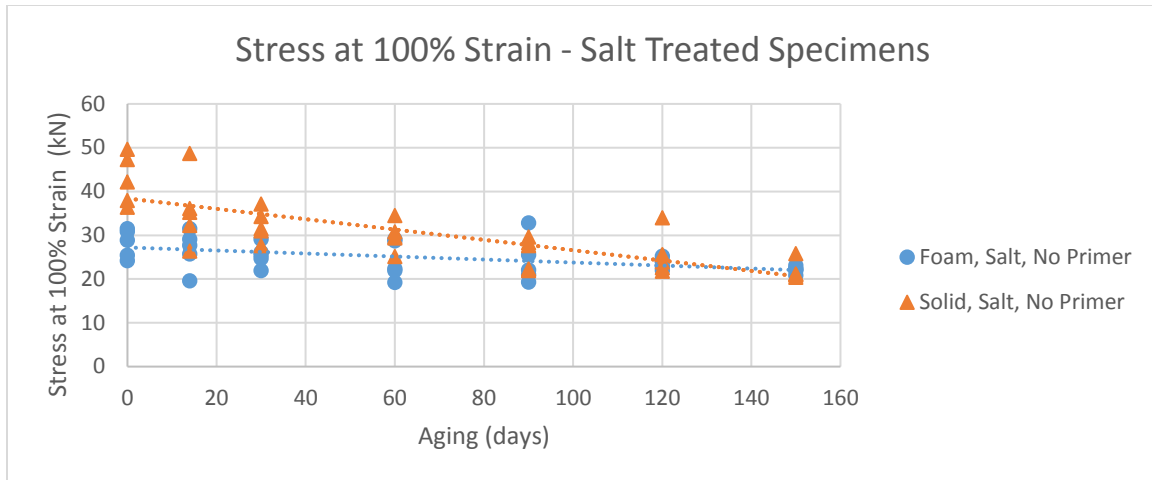
Figure 45: Stress at 100% Strain for specimens exposed to salt and no primer treatment

Figure 45 shows the behavior of the stress at 100% strain observed in specimens that were aged in the salt water tank, but did not receive primer treatment prior to immersion. Once again, the modulus of the solid sealant appears to decrease at a higher rate than that of the foam sealant. The stress at 100% strain of specimens containing primer at 0 days (no aging) was measured to be approximately 39 kN. Over an aging period of 5 months, the stress dropped to about 21 kN, a reduction of 46.1%. The foam sealant also exhibited a decrease in stress, but not as sharp as the solid sealant. The foam sealant's initial stress at 100% strain was observed to be about 27 kN, dropping to about 23 kN after 5 months aging. This represents a reduction in stress of approximately 14.8%. Again, the t-test confirmed the difference in these slopes, generating a t-value of 4.305 and probability of less than 0.001.

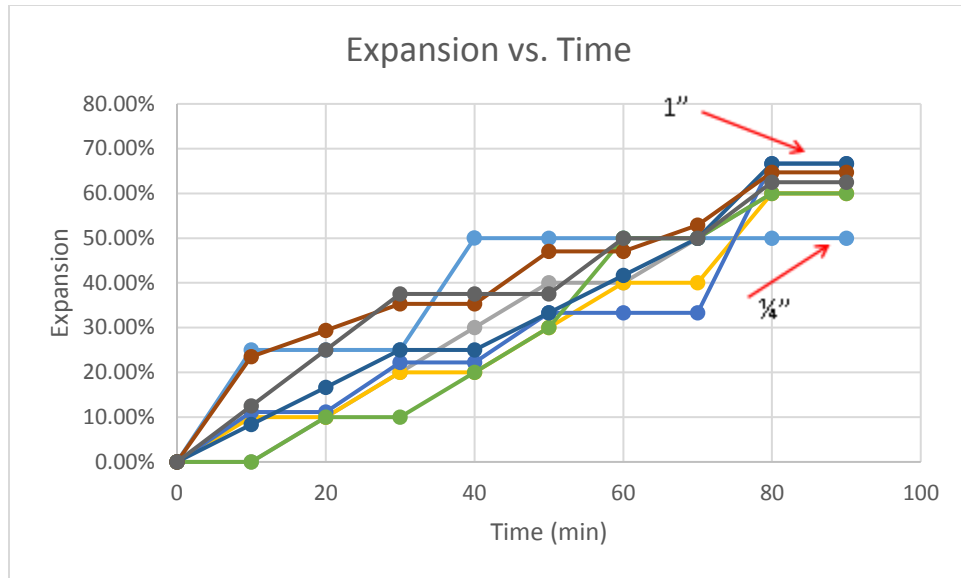
Figure 53: Expansion vs. time for foam sealant.

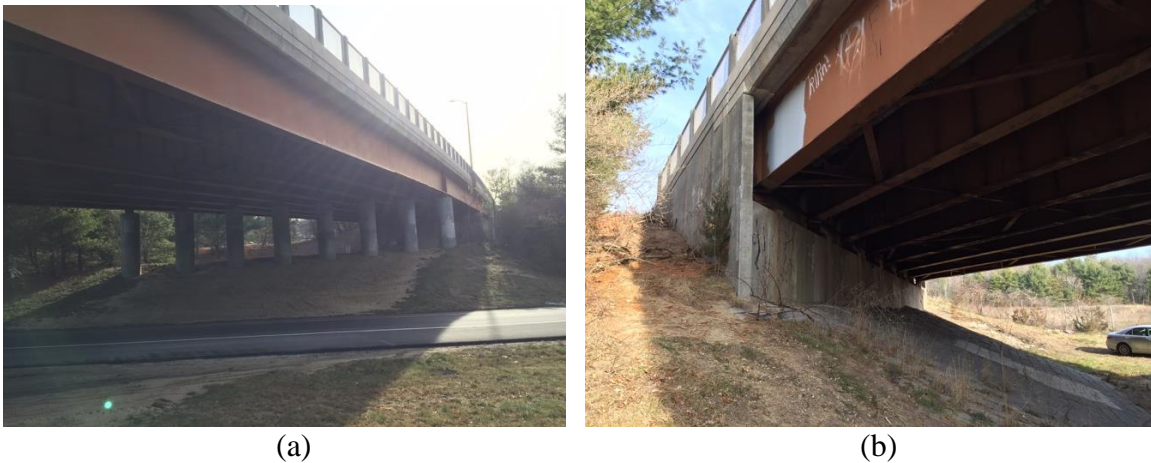
Figure 55: Span and center pier (a), support at abutment (b)

The first bridge is located in Windham, CT, comprising of two 170 ft. spans over the Route 6 expressway. Although the bridge spans over Route 6, vehicles travel under the bridge as part of Route 6 and circle around to travel on the bridge itself, still as part of Route 6 (Figure 54). This 8 girder composite bridge contains a steel girder superstructure and 7.75-inch concrete road deck (with concrete joint headers). A 2.5-inch bituminous concrete wearing surface and waterproofing membrane rests on top of the concrete deck. According to the 2013 Bridge Safety Inspection report, the anticipated daily traffic (ADT) for this bridge is 15,700 vehicles. The bearings are fixed at the pier, so each abutment joint accommodates movement over a temperature range of -10 degrees Fahrenheit to 110 degrees Fahrenheit, resulting in a theoretical movement of each joint of approximately 1.53 inches as per AASHTO specifications (AASHTO 2012). The speed limit on the bridge is 45 miles per hour. The state of Connecticut previously installed a silicone sealant which failed after an unknown period of time. Typically, they would install an asphaltic plug joint (APJ) to repair joints of this nature; however, the total movement of this bridge exceeds the capabilities of the asphaltic plug joint. Therefore, the silicone foam sealant joint was a good candidate for this bridge.

The installation of the expansion joints of the Route 6 bridge was a two-day operation, conducted on Monday and Tuesday, September 14-15, 2015. Lane 1 and the south shoulder (shown in Figure 55) were installed on Monday, September 14. Weather conditions for Monday were

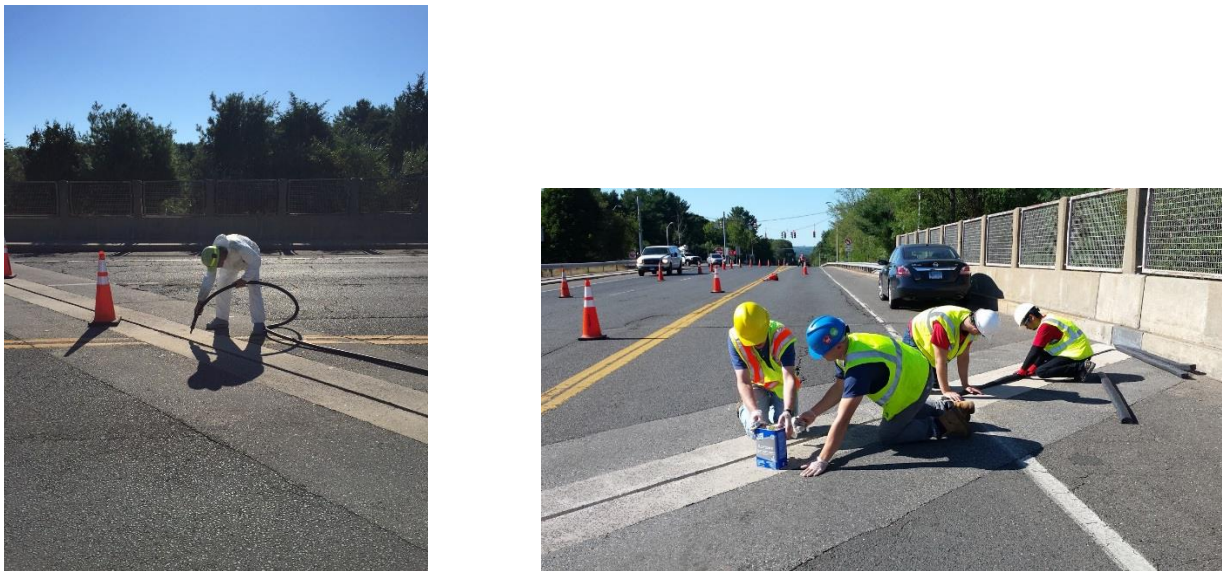
Figure 57: Sandblasting and primer application onto the Route 6 bridge joint

The preparation of the joint (Figure 57) prior to actual installation of the sealant involved removing the existing joint and sand blasting the header to ensure any remnants of the previous joint were removed. Since this particular bridge was sealed using a poured silicone joint in the past, care was taken to ensure no remnants of the silicone joint were remaining on the substrate. This was to optimize the bond between the new foam sealant and the substrate. Once the surface was free of any loose material, a rag was used to apply a thin coating of acetone to the header of the bridge to remove any oils that may be present on the surface of the header.

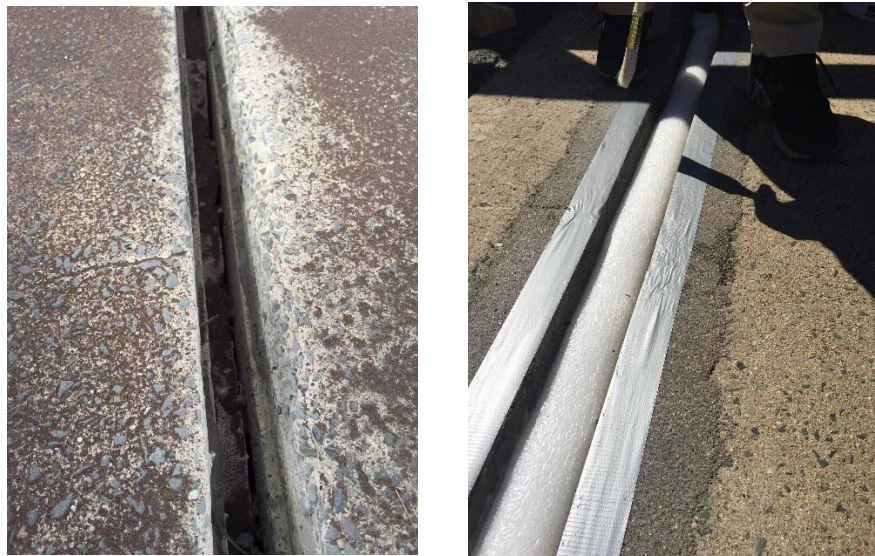
Figure 58: Overview of the joint (a) before backer rod installation and (b) after installation

After cleaning the joint from any loose debris or oils, primer was applied in locations as prescribed by the placing pattern shown in Figure 60. The top surface of the joint header was lined with duct tape to prevent any silicone from sticking to the roadway. This also allowed for a clean termination line between the edge of the substrate and the silicone sealant. A 3-inch backer rod was inserted 1 inch below the surface of the road using a T-shaped spacing tool. The vertical

portion of the spacing tool was exactly one inch, which allowed for a consistent recess of the backer rod along the joint. The backer rod was a 3-inch diameter closed cell, polyethylene extruded foam rod with excellent UV and moisture resistance. The joint was air blown after installation of the backer rod to remove any sand or debris that may have been carried into the joint after initial cleaning. Dividers were placed at the boundary sections (between the foam and solid sealant) to ensure the foam sealant did not spill over into the portion designated for solid sealant. The final configuration of the joint prior to pouring the silicone sealant is shown in Figure 58 (b).

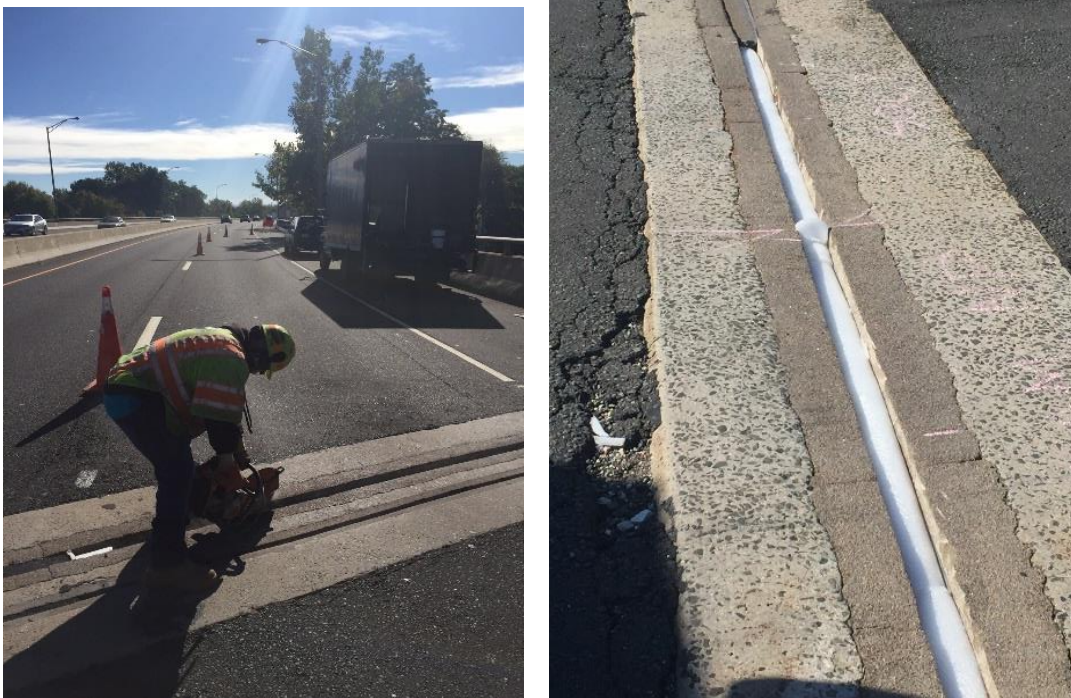
Figure 63: Joint preparation on the Route 291 bridge

The preparation of the joint prior to installation of the sealant involved removing the existing joint, which was coordinated by the Connecticut Department of Transportation as a night job conducted prior to installing the new expansion joint. This was done to save time and avoid

disrupting traffic on the day of installation. The header was thoroughly sand blasted to remove any loose material and remnants of the old joint. Additionally, a large blade saw was applied to the header to cut into the concrete and expose a fresh surface for optimal bond. Dividers were placed at the boundary sections (between the foam and solid sealant) to ensure the foam sealant did not spill over into the portion designated for solid sealant. Finally, a rag was used to apply a thin coating of acetone to remove any oils that may have potentially been left on the surface.

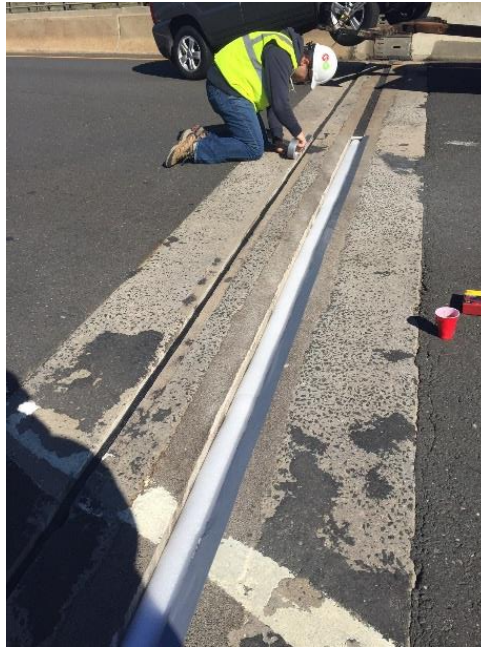
Figure 65: Installation of backer rod and duct tape lining

Once primer was applied to the appropriate locations, the top surface of the joint header was lined with duct tape to prevent any silicone from sticking to the roadway. A 5-inch backer rod was inserted 1 inch below the surface of the road using a T-shaped spacing tool. The vertical portion of the spacing tool was exactly one inch, which allowed for a consistent recess of the backer rod along the joint. The backer rod was a 5-inch diameter closed cell, polyethylene extruded foam rod with excellent UV and moisture resistance. The joint was air blown after installation of

the backer rod to remove any sand or debris that may have been carried into the joint after initial cleaning.

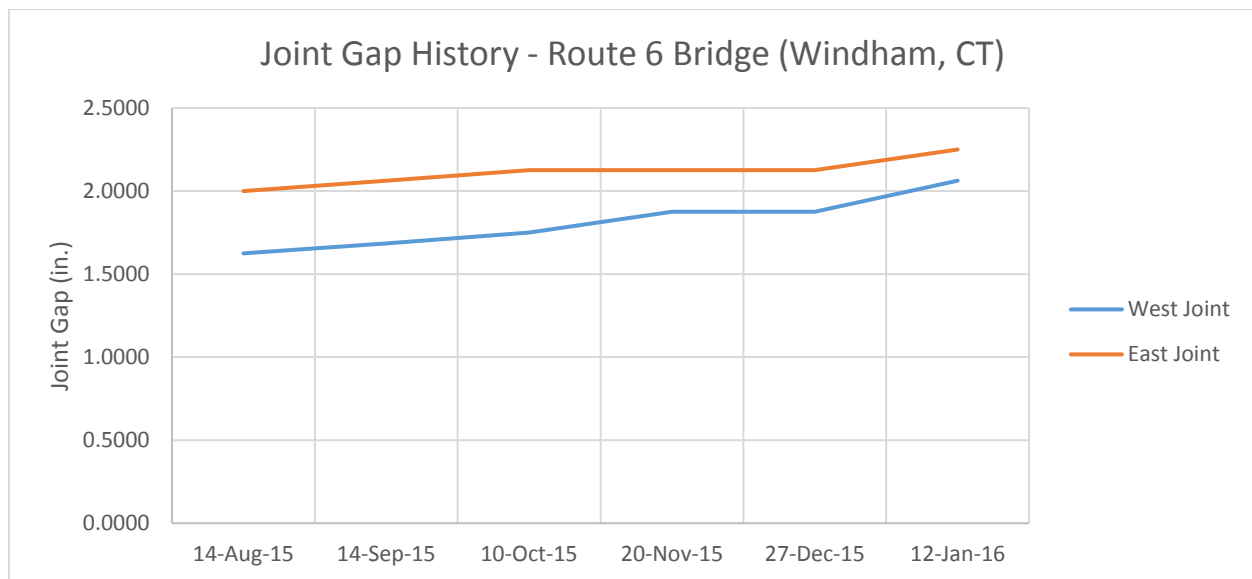
Figure 70: Joint gap history for Route 6 bridge

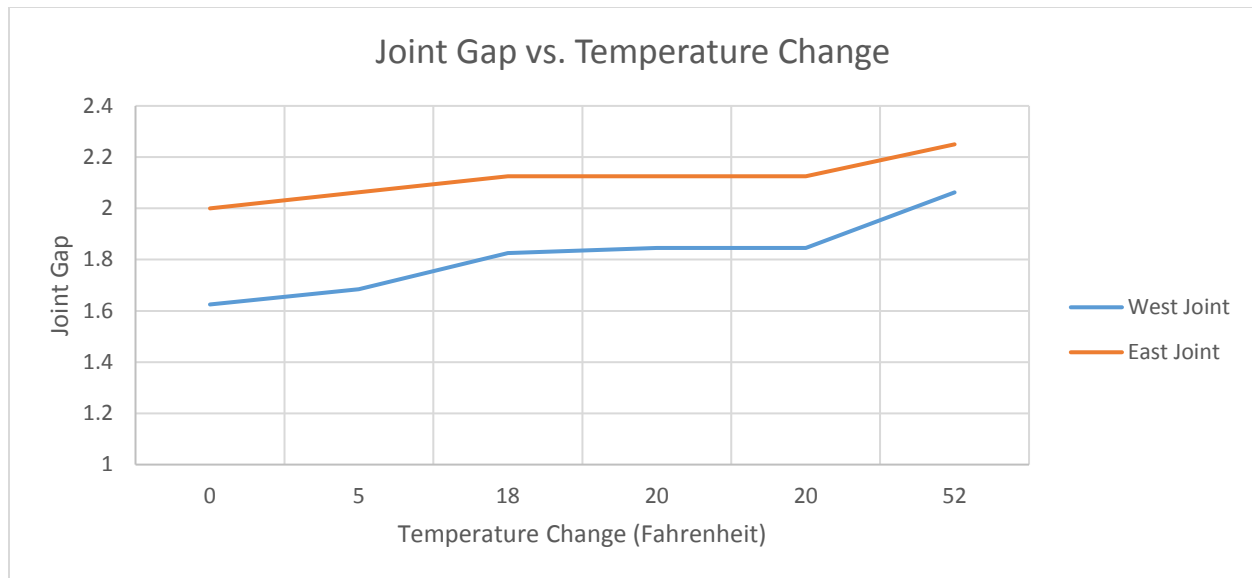
Figure 71: Joint gap as a function of temperature change for Route 6 bridge

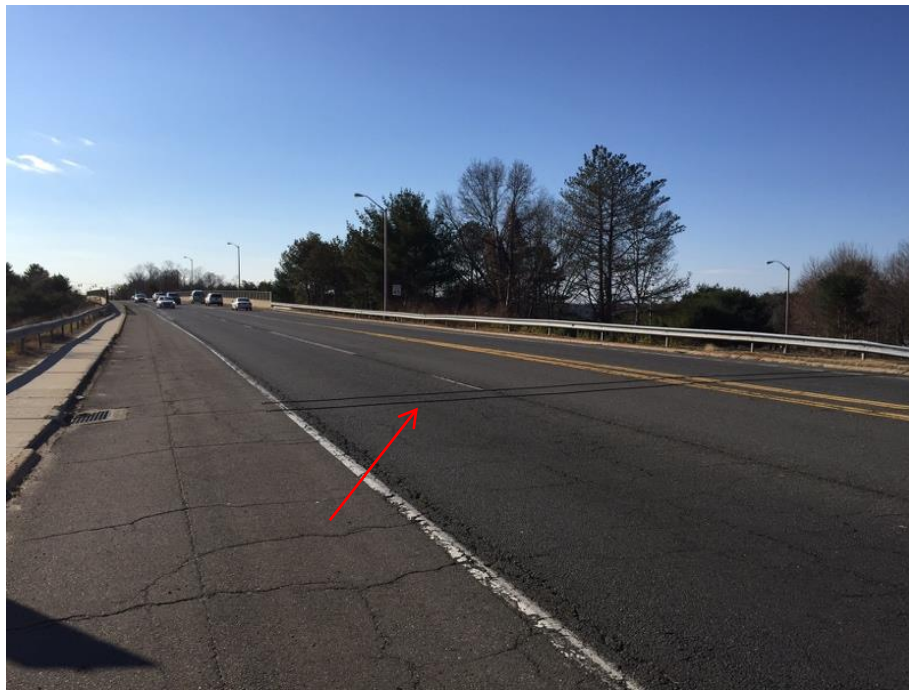
Figure 72: Location of traffic counter

The tubes were installed by nailing metal clamps to road at the outer edges of the roadway. These clamps secured the tubes at each end, while a wire loop held the tube in place at the median.

The wire loop was installed to allow for some movement of the tubes as vehicles drive by; if the tubes were clamped at all three locations, vehicles could rip them off in between the two clamps. Therefore, the wire loop provided some flexibility when the vehicles drove over. The west tube was labeled “A” and the east tube was labeled “B”. This convention was established to determine the direction of vehicles travelling over the bridge. The tubes were spaced exactly 36 inches apart; this spacing is commonly used when speed data is also desired. An overview of the location of the traffic counter is shown in Figure 72.

The traffic counter enabled recording of the number, direction, speed and classification of all vehicles driving over the bridge over a specified period of time. Two 6-day periods were chosen for monitoring. The first period monitored was from 8:23AM on Tuesday, November 24, 2015 to 2:54PM on Monday, November 30, 2015. This time period, which falls during Thanksgiving, gave a good indication of regular weekday traffic, holiday traffic, and also weekend traffic. The second

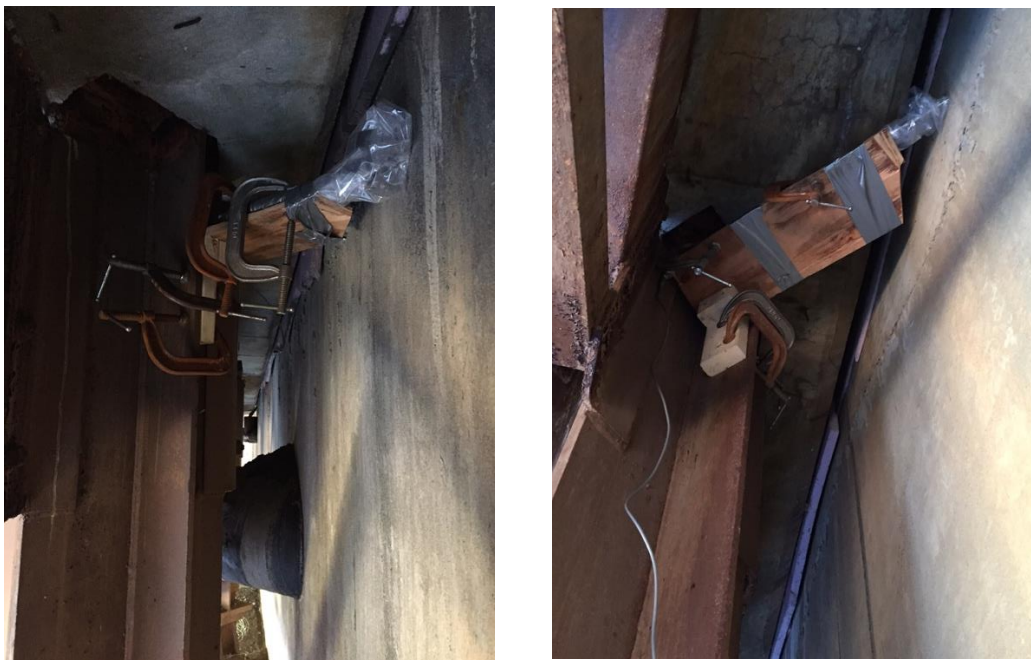
Figure 75: Attachment of LVDT for axial displacement measuring

The next measure taken to monitor the Route 6 bridge was to record the axial displacement of the bridge as a function of vehicular movement. In order to do this, several Linear Variable Differential Transformers (LVDT's) were installed onto the girders of the bridge. The devices, supplied by TransTek, Inc., have a working range of ± 2 inches with an internal carrier frequency of 1500 Hz. The LVDT's were wrapped with plastic sheeting and duct tape to prevent any moisture from damaging the internal structure of the device. The distance between the end of the girder and the abutment was approximately 16 inches; therefore, the LVDT alone could not reach out to make contact with the abutment. In order to attach the devices to the girder and also rest the needle onto the abutment, a wooden angle was constructed and clamped to the girder in such a way so that it

extended to the abutment. Since the devices are spring loaded, they were mounted onto the girders with the needle placed against the abutment (Figure 75). The joints on this bridge are skewed (42 degrees for the west joint and 45 degrees for the east joint). To prevent the needle from slipping off of the abutment, a small hole was drilled into the abutment into which the needle was placed to ensure a proper mounting location. One LVDT was attached onto a girder at two different locations along the east joint. LVDT #1 was attached onto Girder 3 and LVDT #2 was attached onto Girder 6. This placement was designed to gather displacement data at symmetric locations from the edge of the deck, and also monitor the activity at the center of the east and westbound lanes.

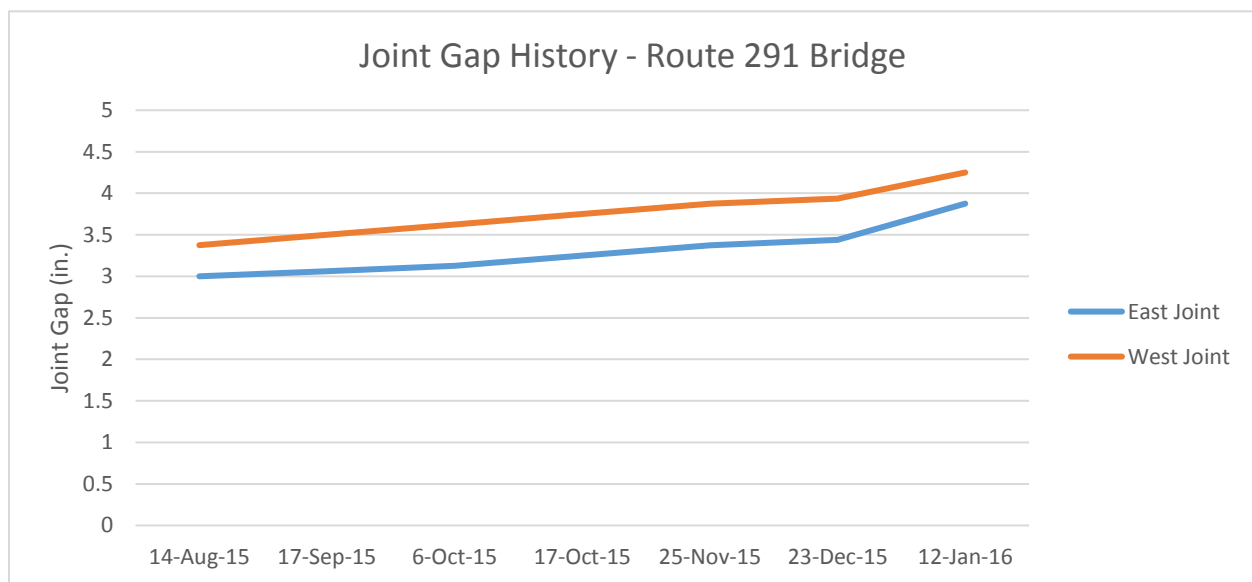
Figure 76: Joint gap history for Route 291 bridge

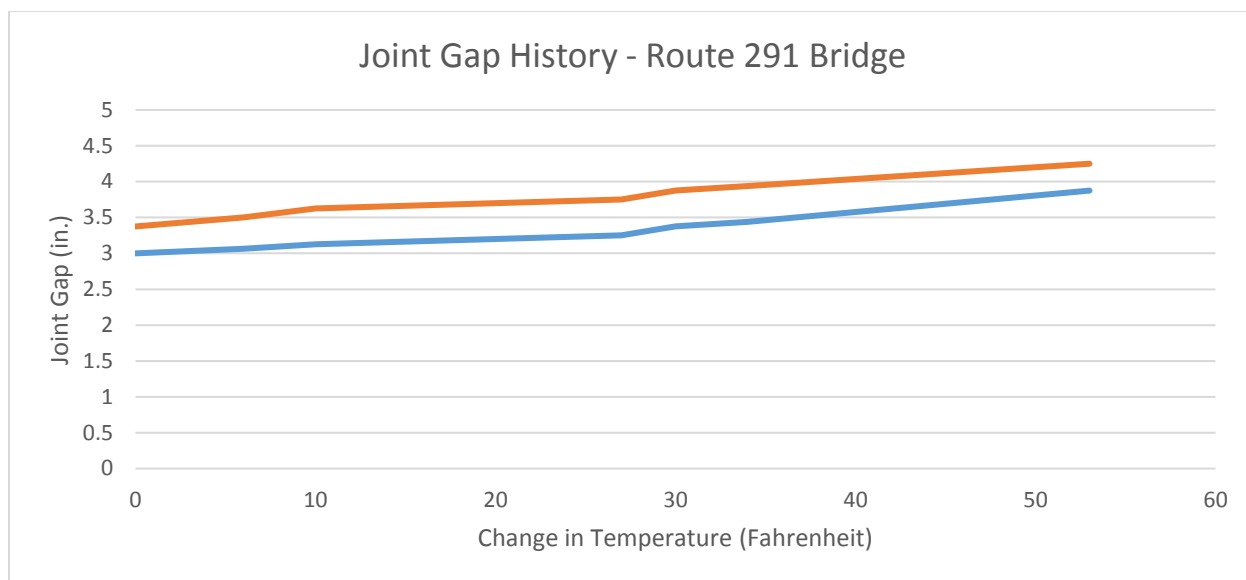
Figure 77: Joint gap vs. change in temperature for Route 291 bridge

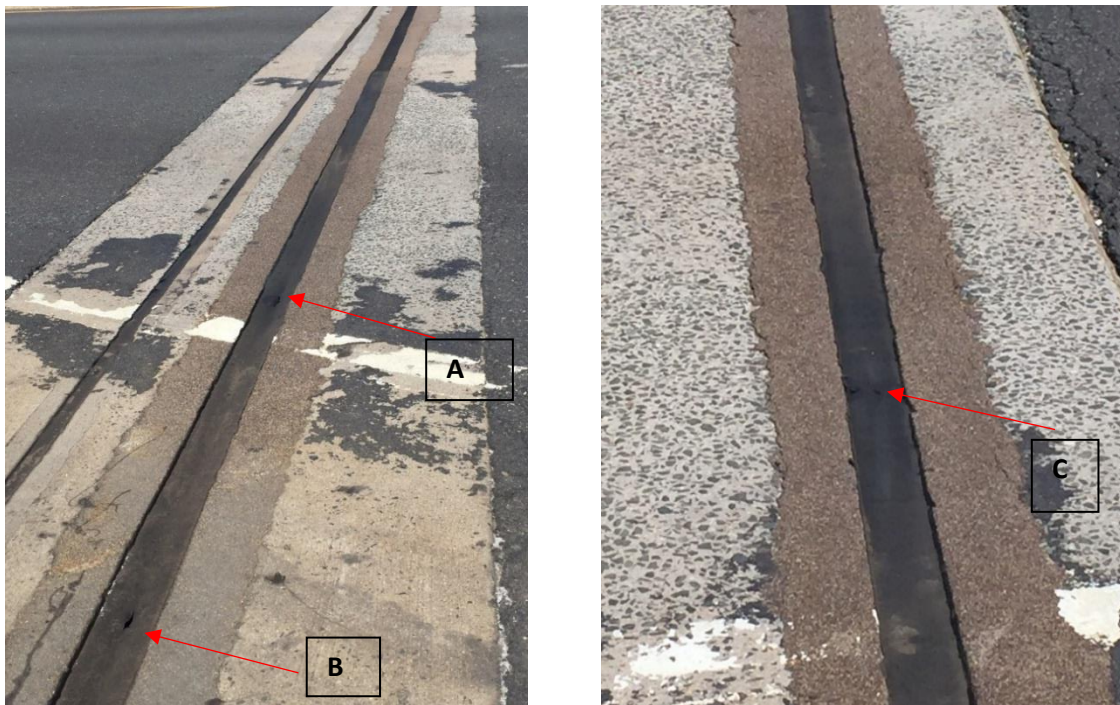
Figure 80: Visual observation of damage on the Route 291 bridge

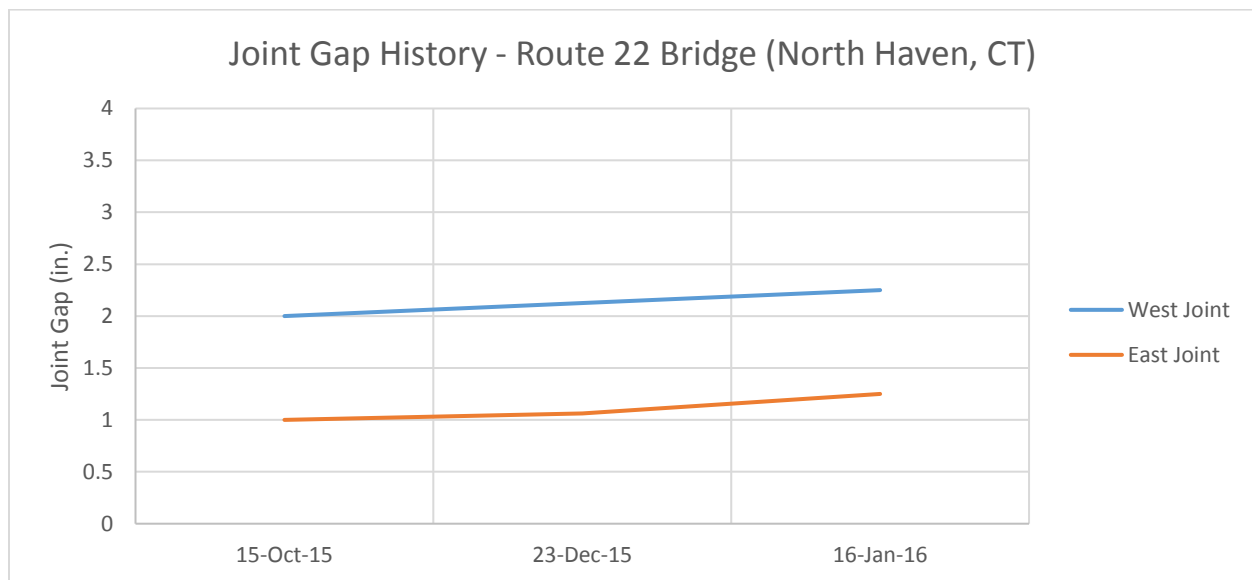
Figure 78: Joint gap history of the Route 22 bridge (North Haven, CT)
